Design-Build 48-Hour Replacement of LIRR's Post Avenue Bridge Using SPMTs

Vicki Christini, PE

June 4, 2019

NYSCHSA
Business Meeting

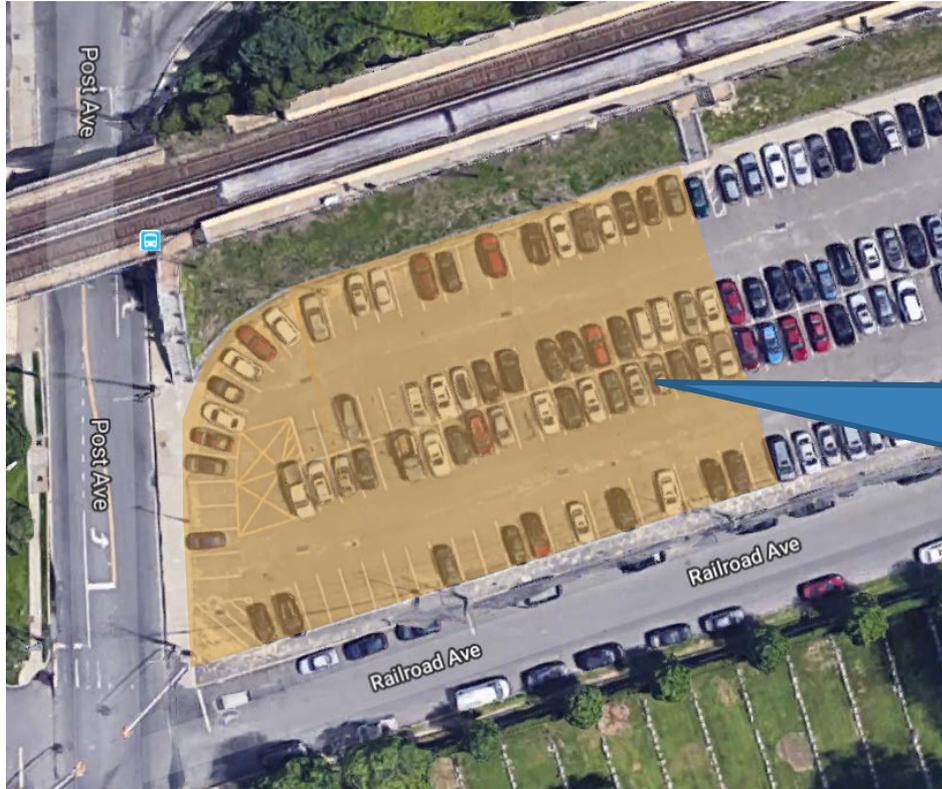
Parking Lot Capture - 3

Phase 2
Capture Zone
80 + Spaces
August 2017

Bridge Erection

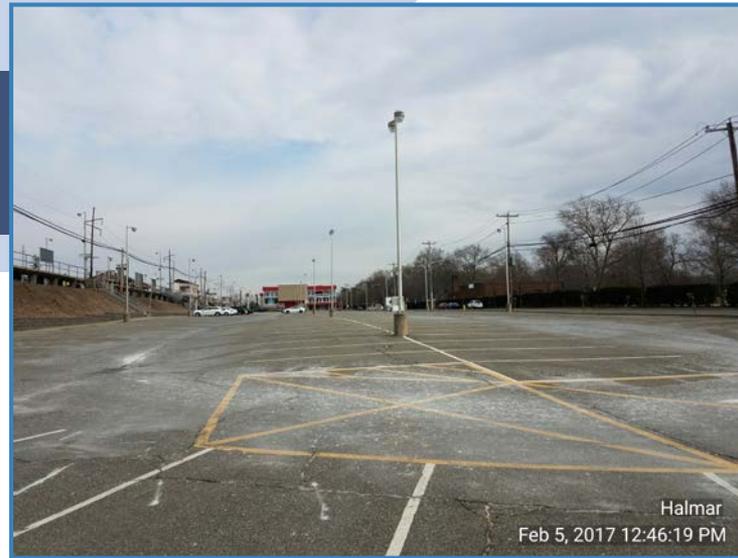
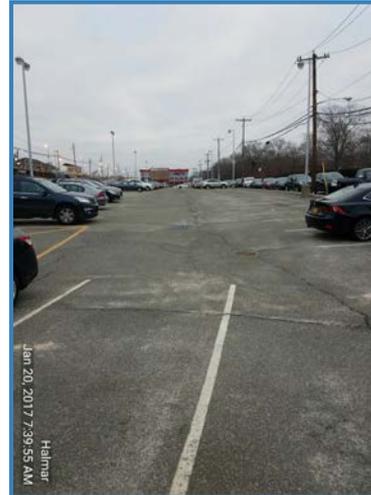
Parking Lot Conditions

- Pavement Slope in Lot is 2%
- Grades & Elevation Differences
- Drainage
- Light Poles

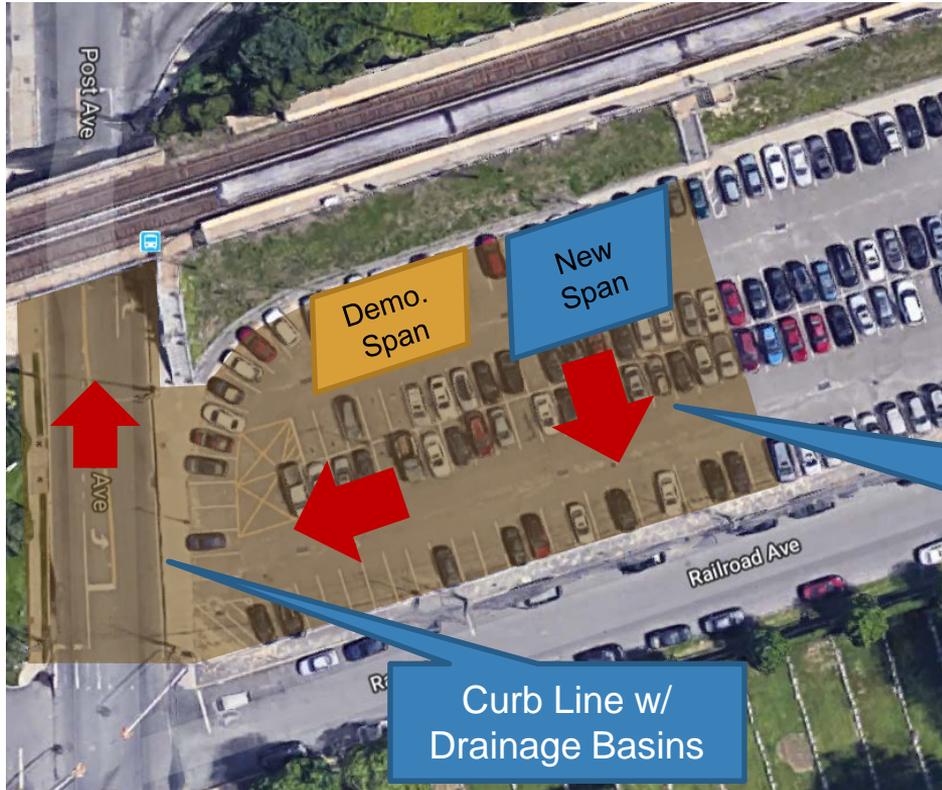
Self - Propelled Modular Transporter Path

SPMT Example

Travel Path Slopes $< 1\%$ for SPMT Path
Entire Area Covered with Sand Fill & Steel Plates to Create SPMT Path

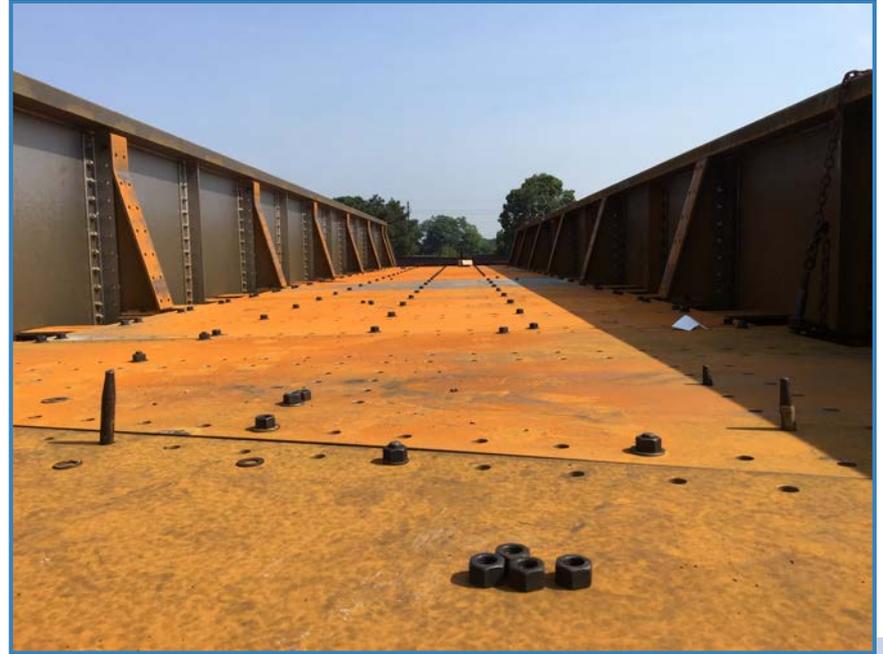
New Superstructure Fabrication

Steel pre-assembled in Fabricator's yard, disassembled, then trucked to site

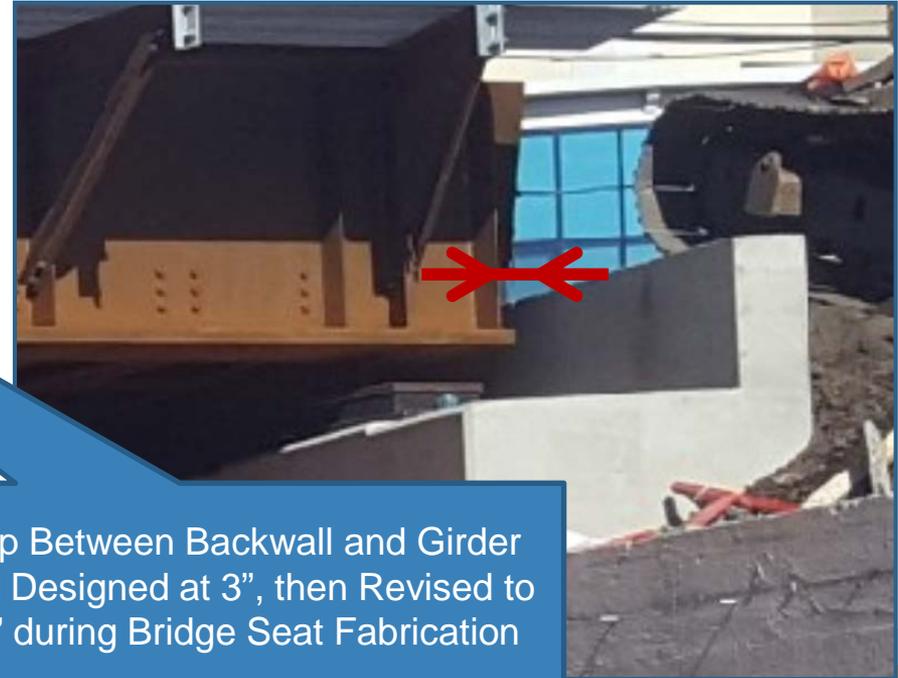
Precast Concrete Bridge Seat - Joint

Gap Between Backwall and Girder End Designed at 3", then Revised to 10" during Bridge Seat Fabrication

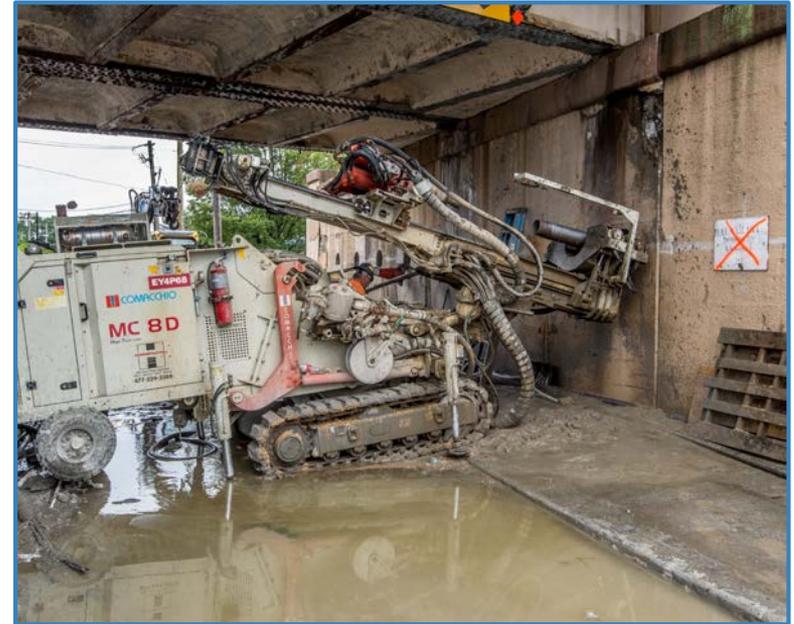
Abutment – Tieback Installation - 1

- LUB : 25 feet
- LB : 35 feet & 65 feet
- Post tension: 50% of design load.

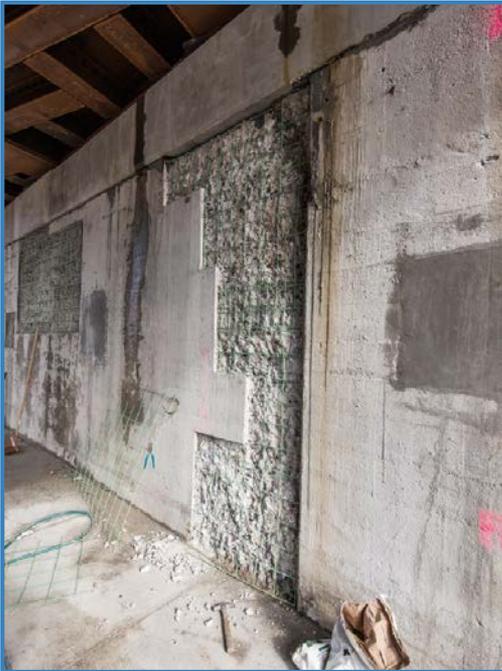
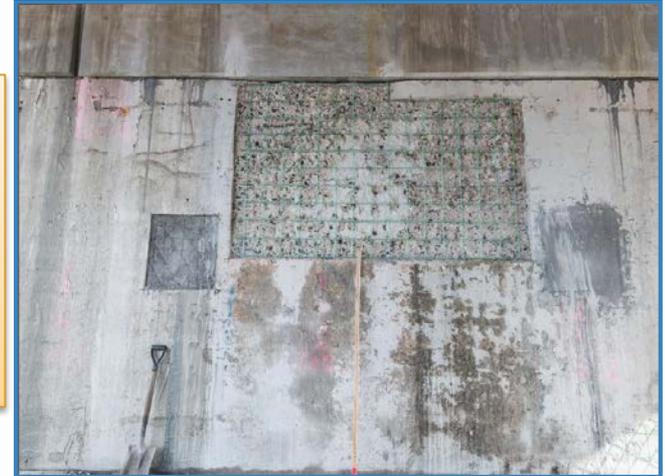
Abutment - Refacing

- Repair Cracks & Spalls
- Fill Tieback Anchorage Pockets
- Apply Protective Coating to Entire Surface

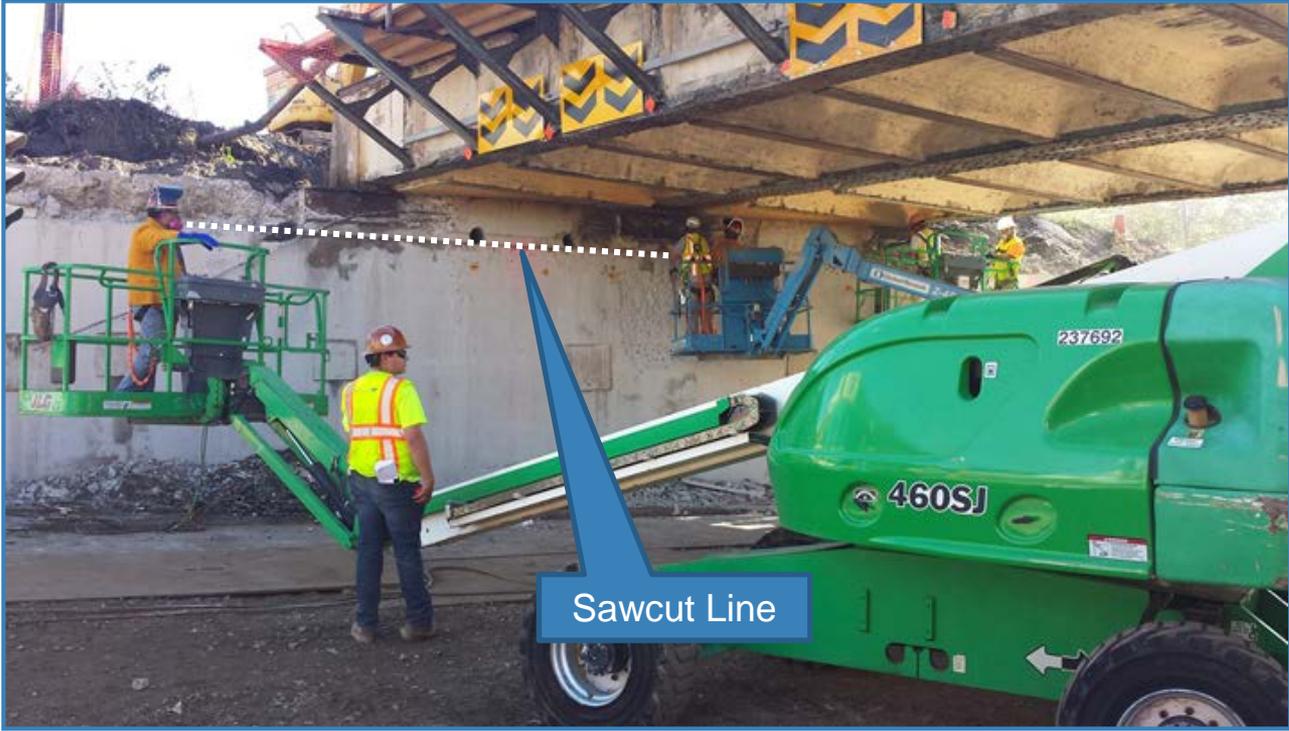
Outage Weekend – Sawcut Existing Bridge Seats - 1

Wire saw cut 1'-6" below existing seat.

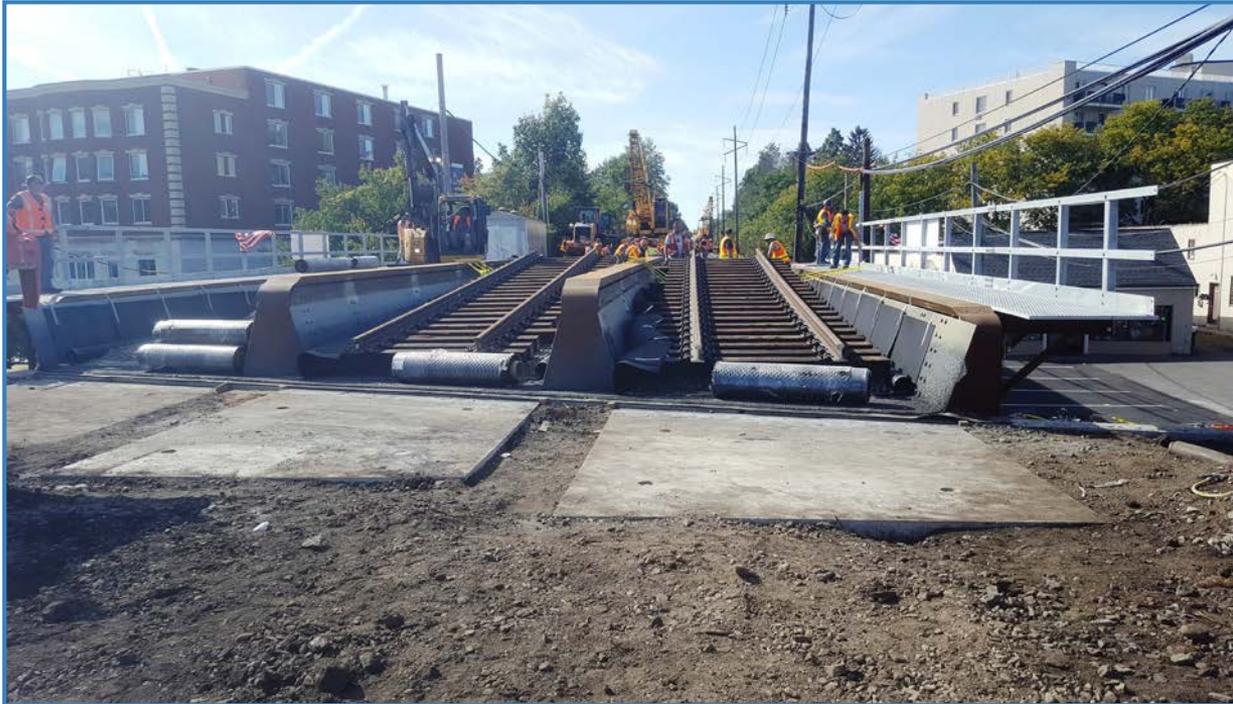
Outage Weekend – Complete Trackwork 1

- Bridge was Rolled-in with Waterproofing, Ballast Mats & Partial Depth Ballast in Place
- Remaining Ballast and Track Sections were Installed After Bridge Was Rolled-in.

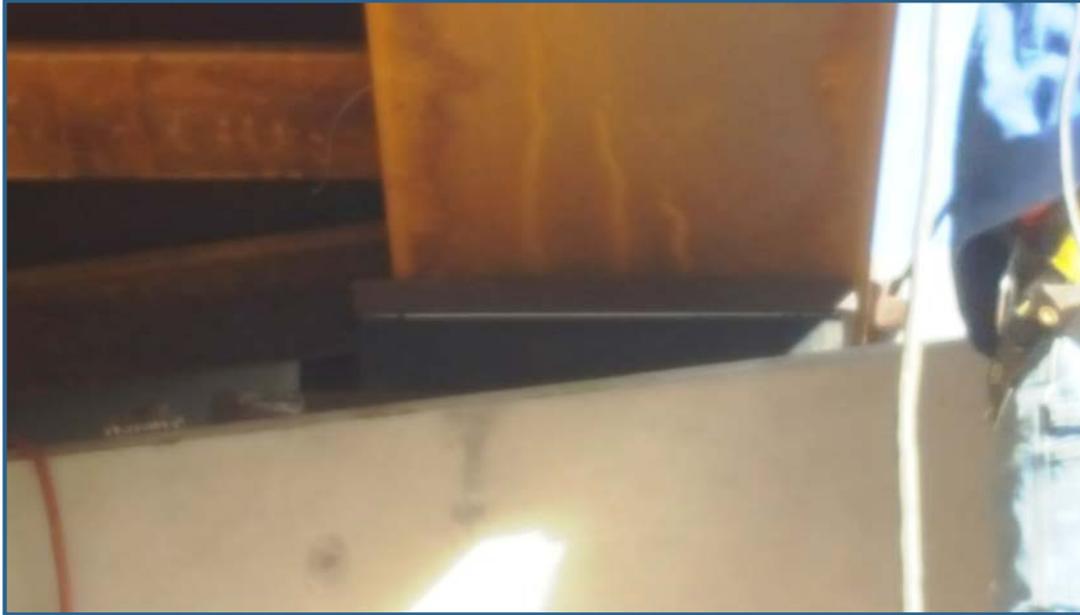
Lessons Learned: During Construction

- Bearings were designed to fit onto bridge seat
- Longitudinal adjustment through slotted holes
- Oversized hole provision for transverse adjustment
- Make sole plate longer than necessary

1. The bridge design life is 75 years.
2. The slope of the SPMT path is 1% or flatter.
3. The key design lesson learned was to oversize the sole plates of the bridge bearings to better seat the girders when landing the bridge on a skew.
