Engineering | Design | Planning | Construction Management

Maintenance & Preservation Techniques for Metal Culverts

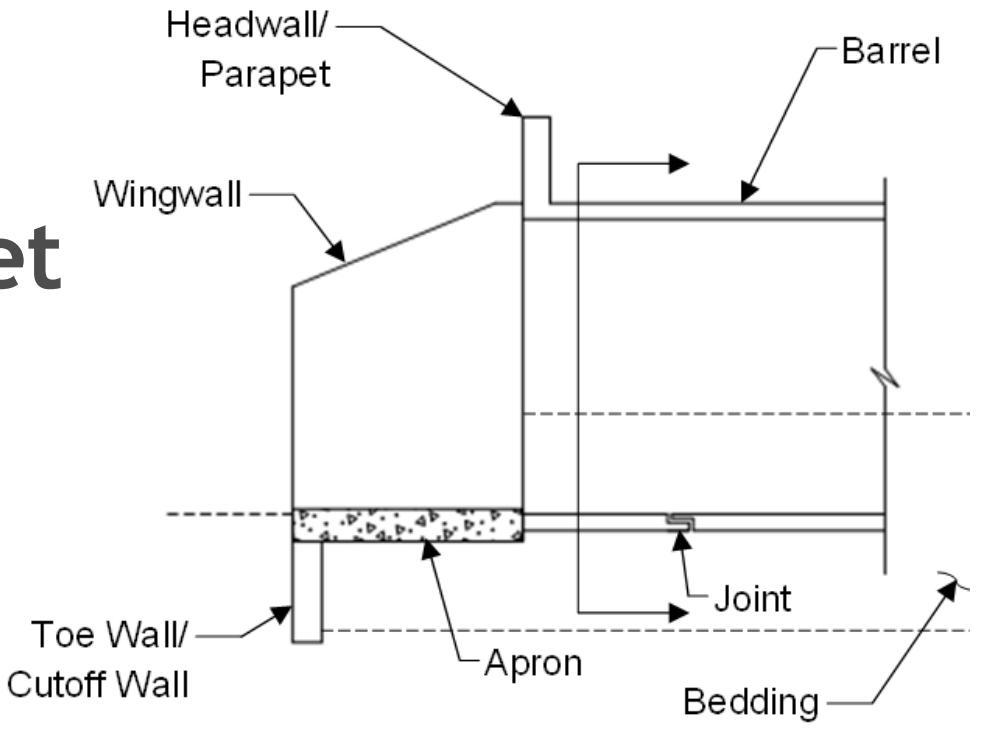
Parts of a Culvert

- Apron
- Toe Wall/Cutoff Wall
- Barrel
- End Section
- Headwall/Parapet
- Joint
- Wingwall

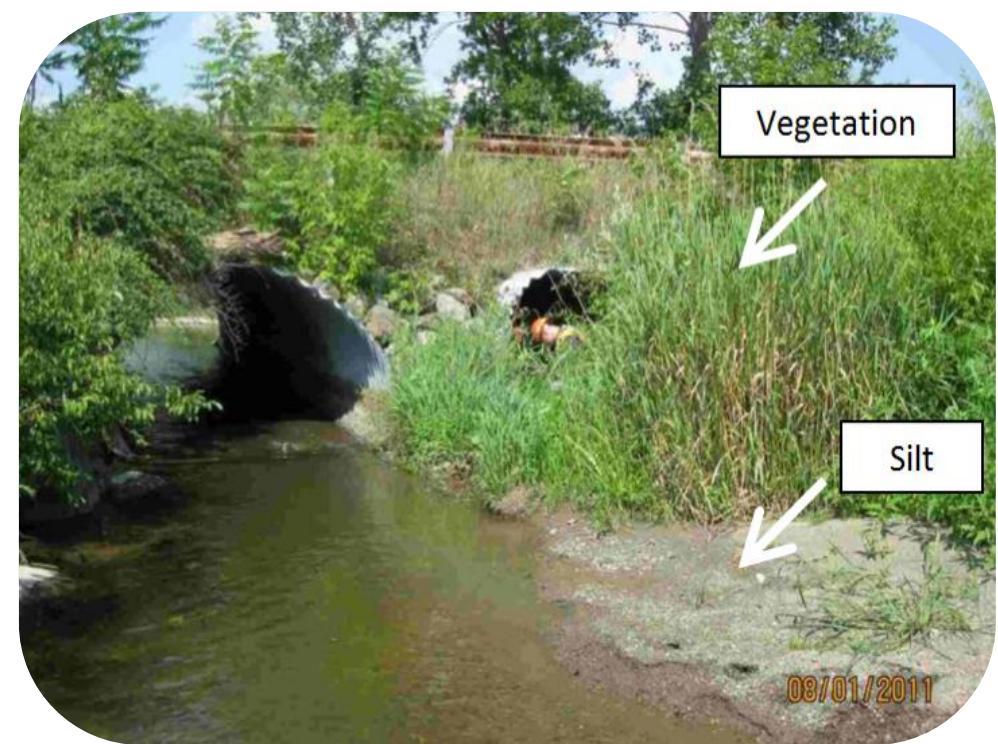
Debris & Siltation

- Reduce capacity of the culvert
- Alter flow through the culvert
- May lead to scour at inlet
- May cause scour outlet
- May cause undermining
- May cause culvert to overtop

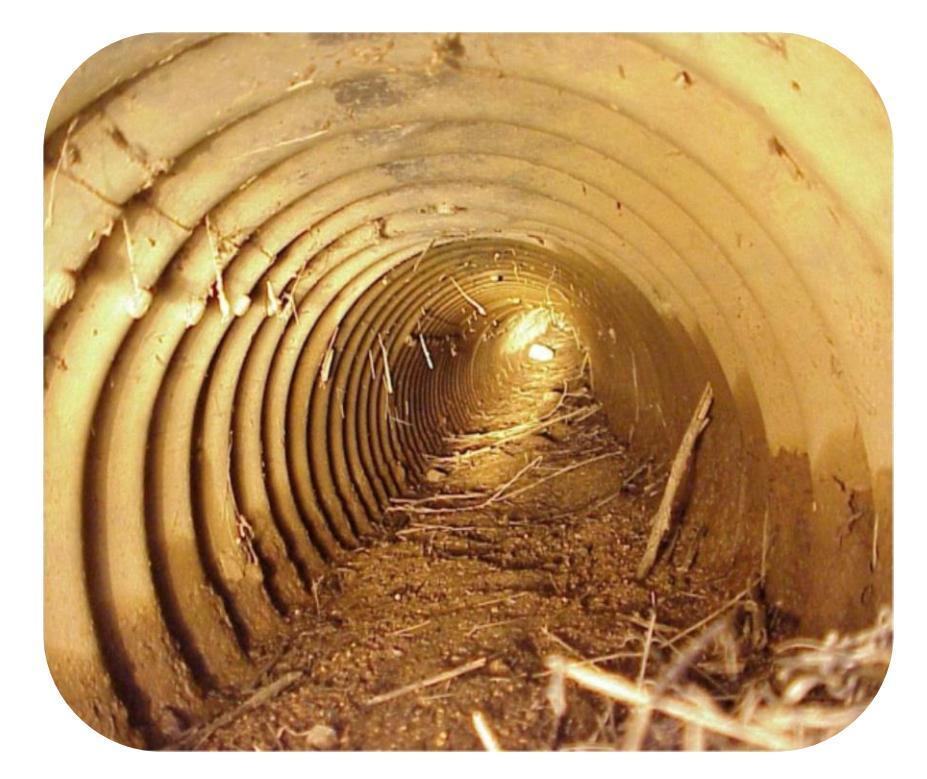
Soil in Culvert

- Reduces waterway capacity
- May be required by environmental considerations
- May result from hydraulics of stream
- May indicate failed joints

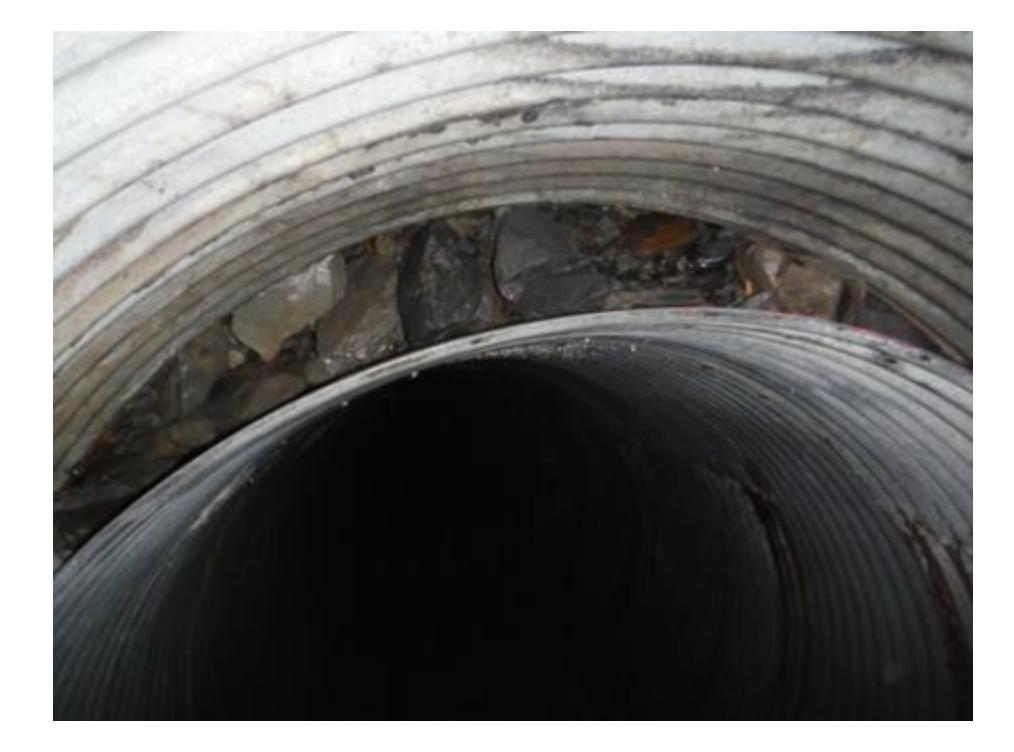
Causes of Leaking Joints

- Separated or misaligned
- Damaged during installation
- Open joints
- Poor bedding / subgrade

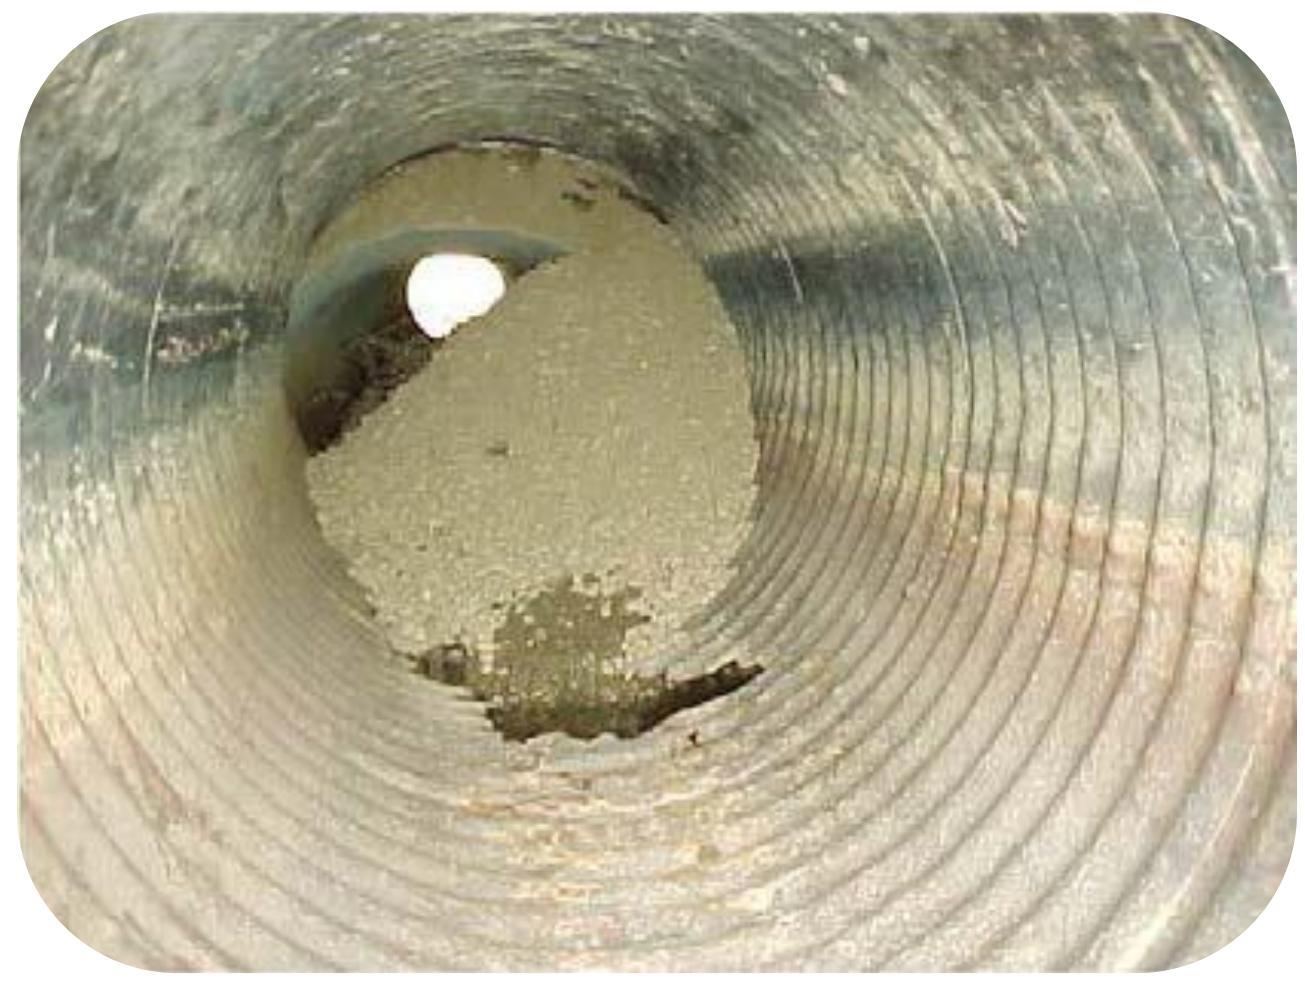
Joint Defects

Joint failure with loss of soil

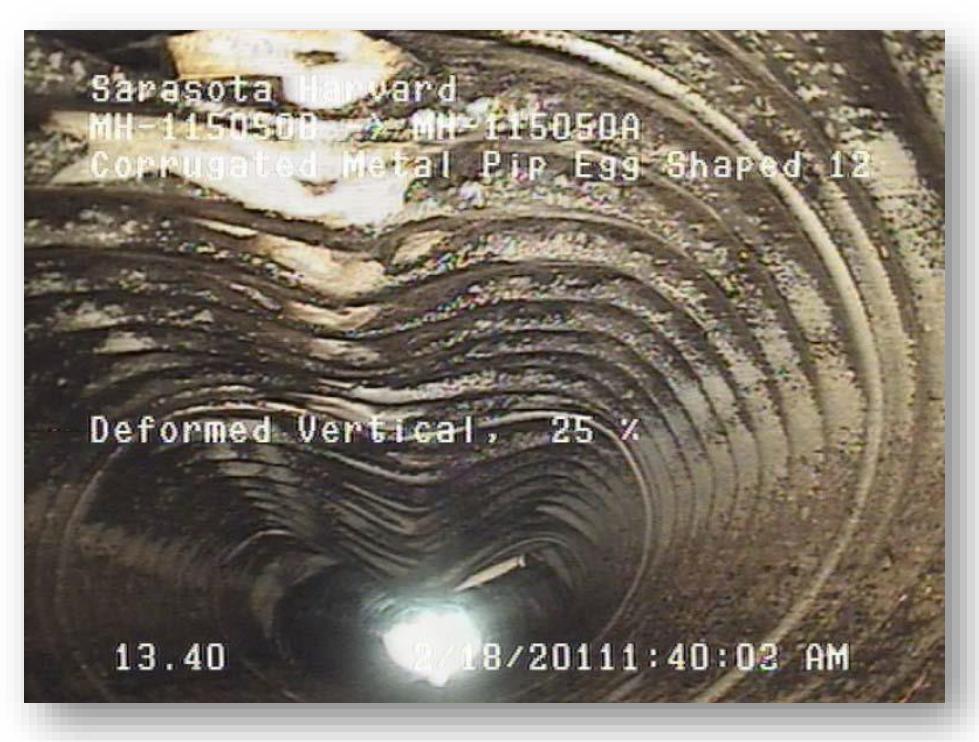
Dents & Localized Damage

- May indicate poor installation practices
- Could have capacity impacts
- Could make
 joint failures
 more severe
- May limit relining options

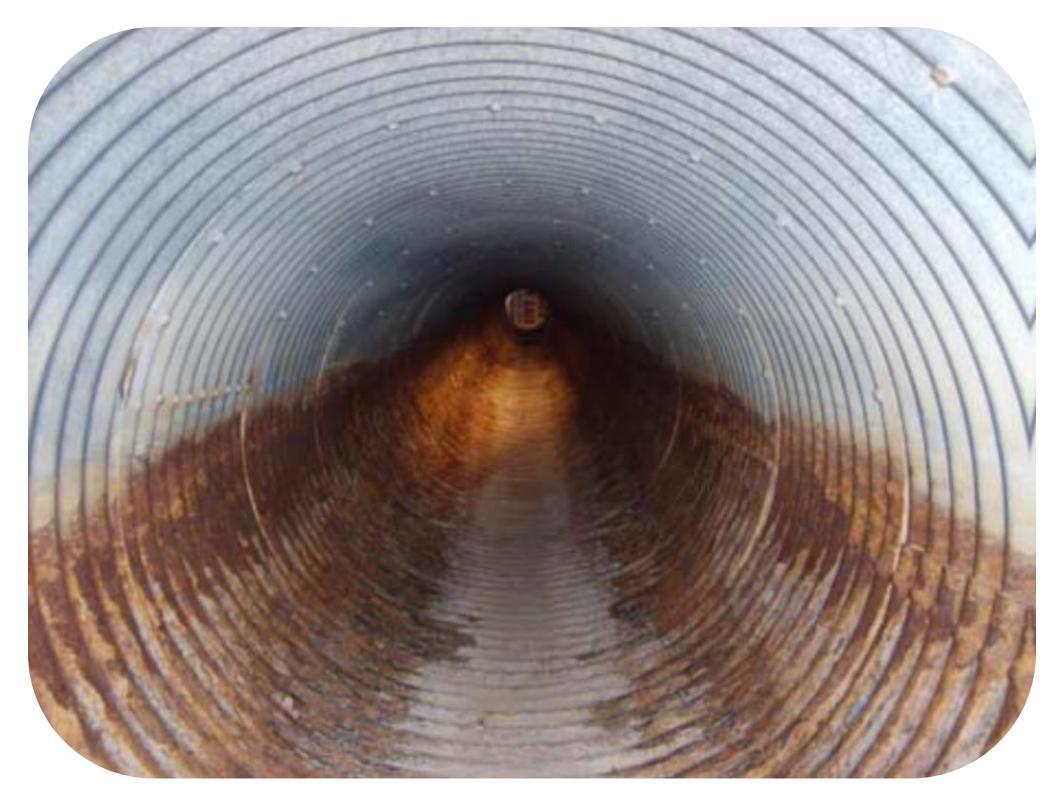
Damaged Coatings

Not typically a problem by itself
 Creates the opportunity for other distresses

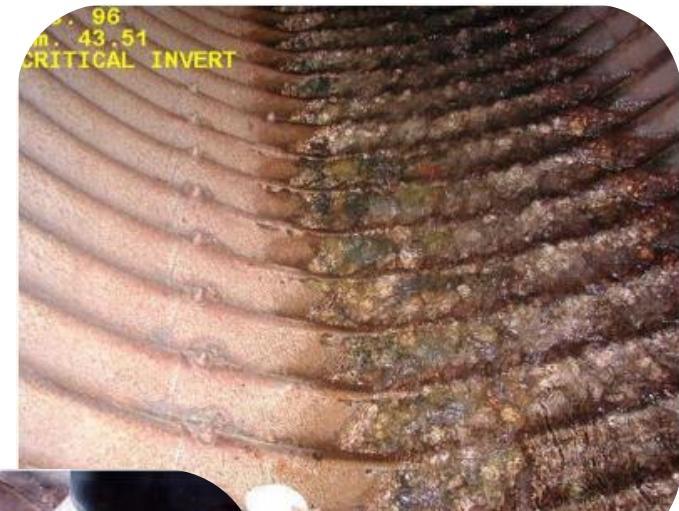
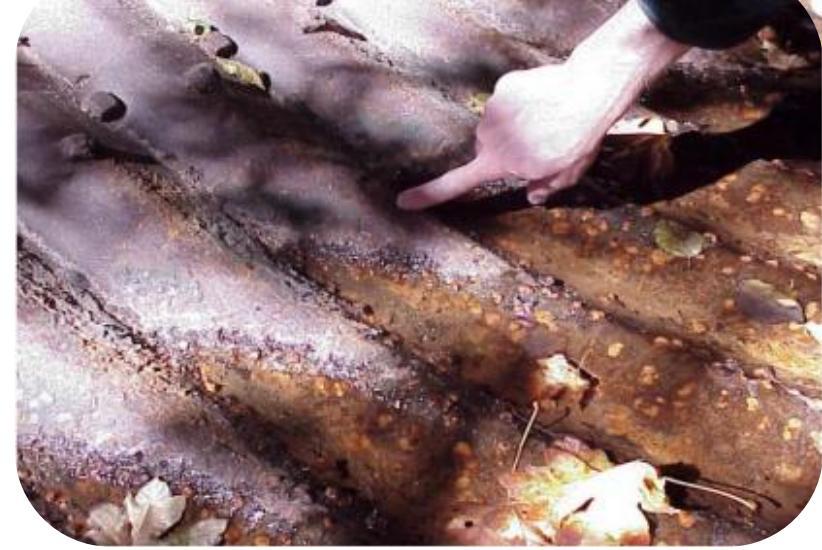
Corrosion will often start with pitting
 Acidic/saline water
 Soils with low electrical resistivity

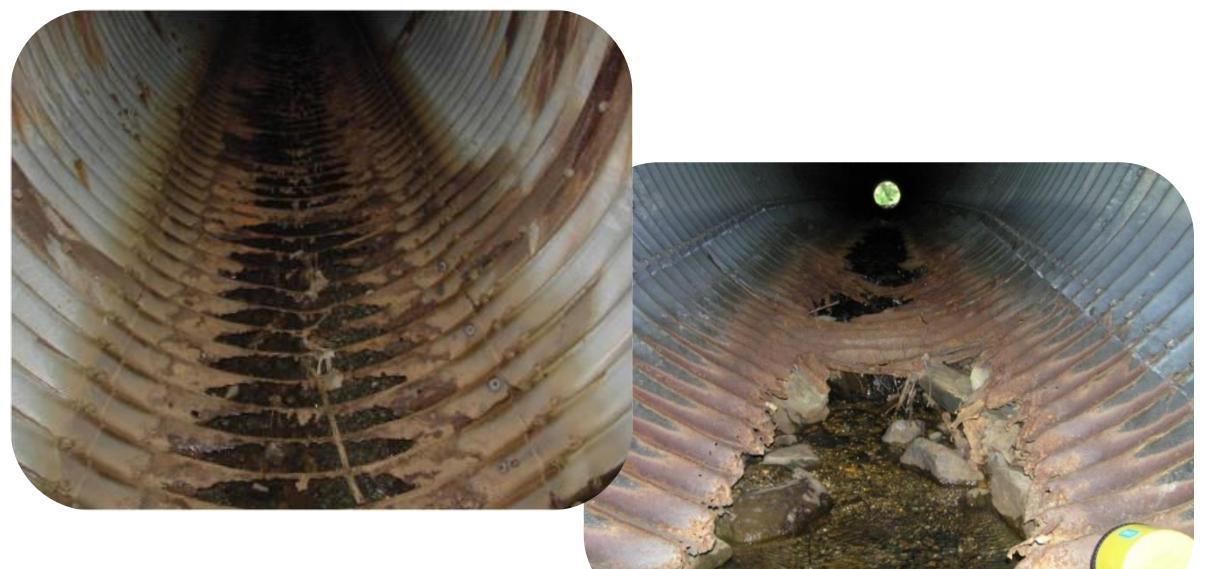
Invert Damage & Deterioration

- Corrosion may be caused by water or soil chemistry
- Damage may be caused by abrasion
- Damage may destabilize culvert

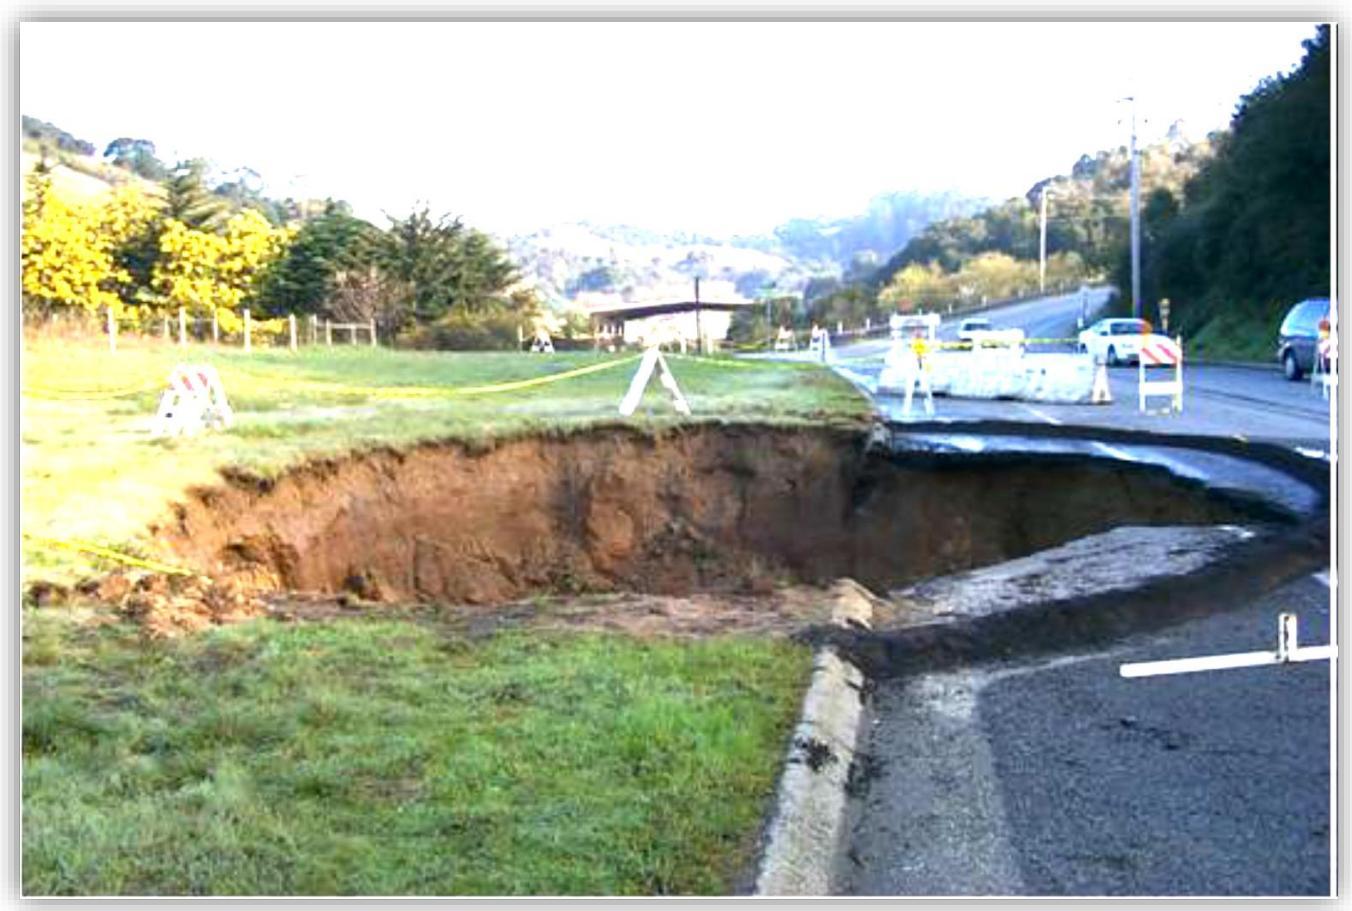
Settlement/Sinkhole

The sink hole is a symptom of another issue
Caused by water carrying soils away

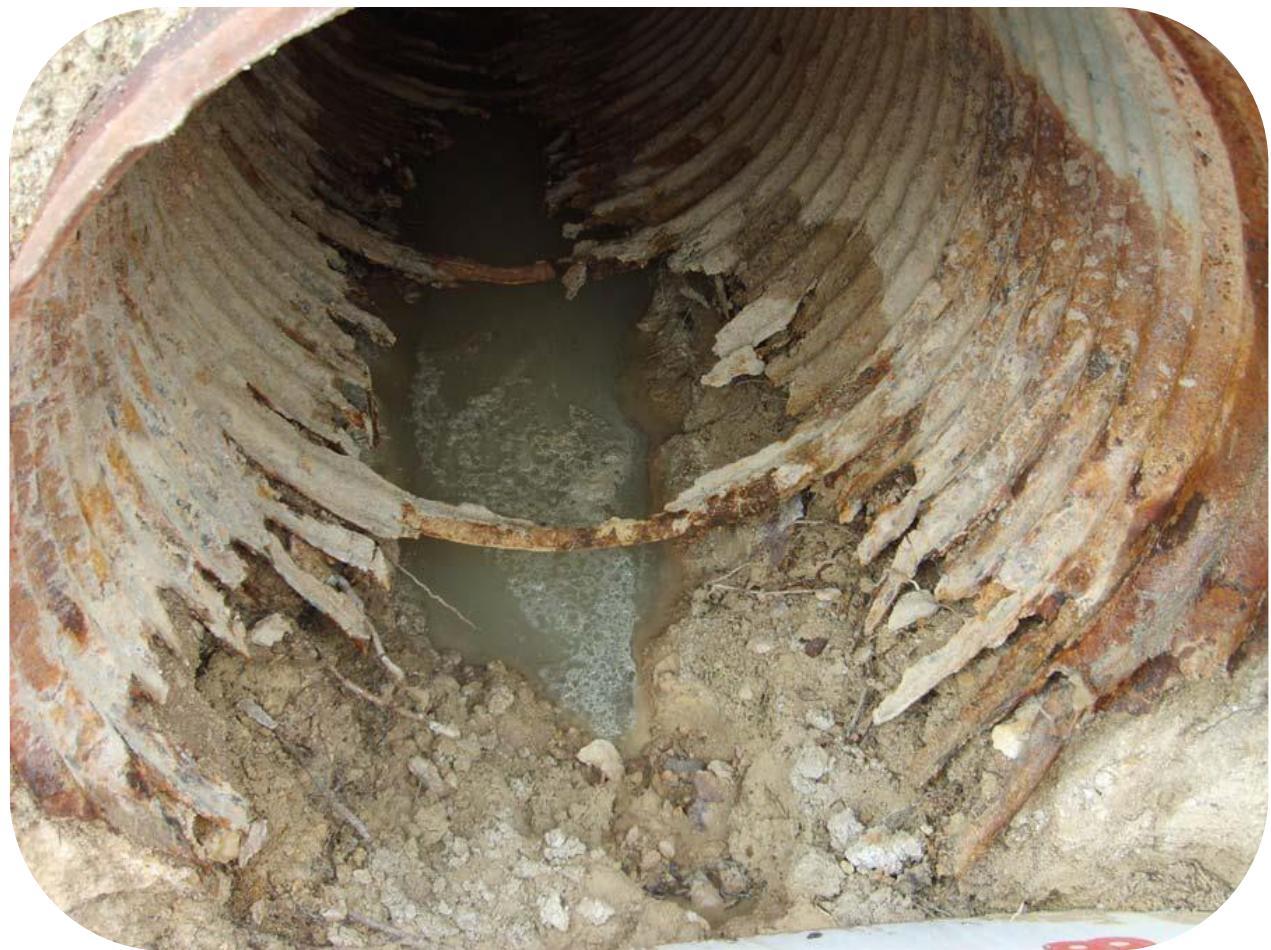
Settlement/Sinkhole (con.)

Failed invert with undermined culvert

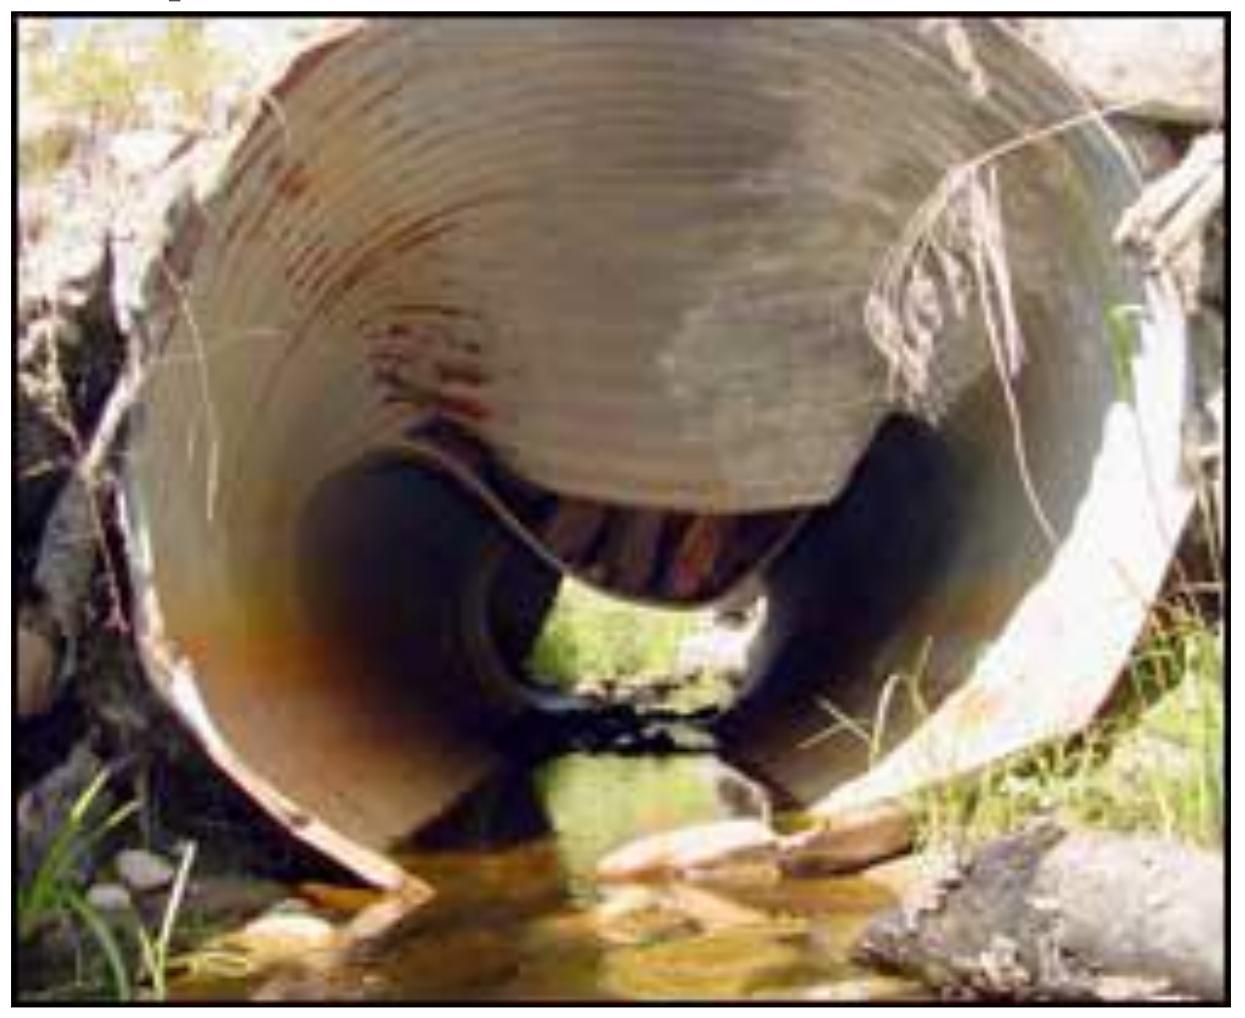
Settlement/Sinkhole (con.)

Collapse

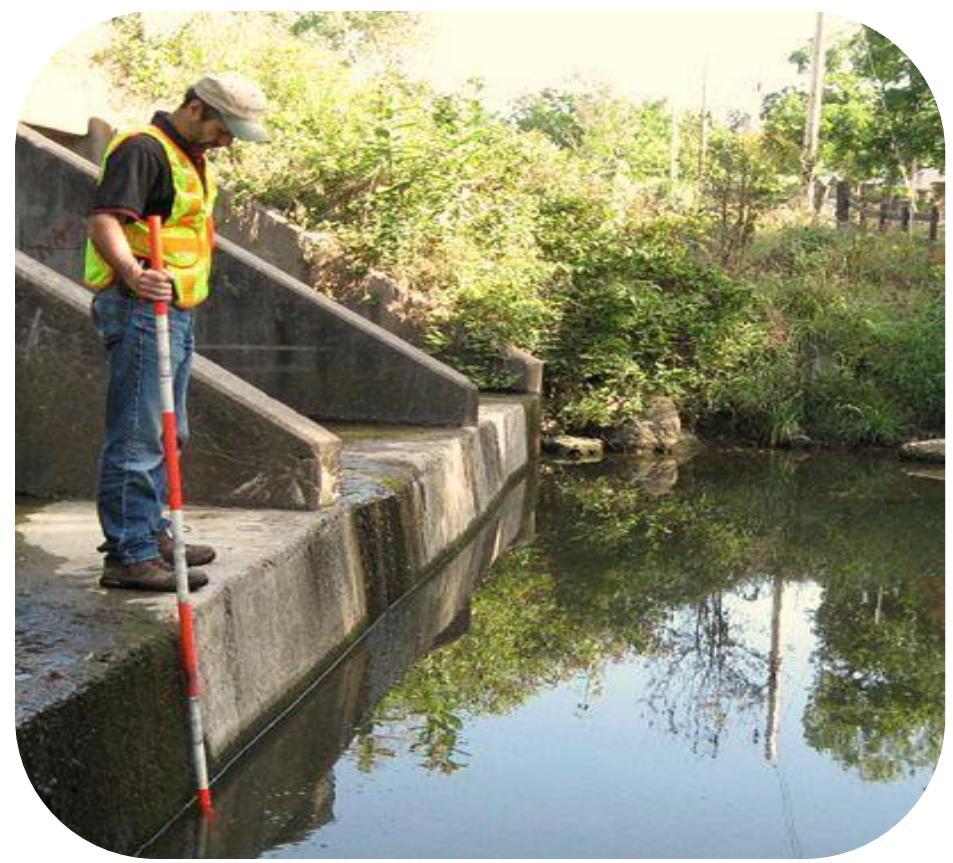
Undermining Repairs > Toe Walls/Cutoff Walls

- May prevent undermining of culvert in scour prone areas
- Will not prevent scour holes
- Must extend below maximum depth of expected scour
- May be used to prevent piping beneath the culvert

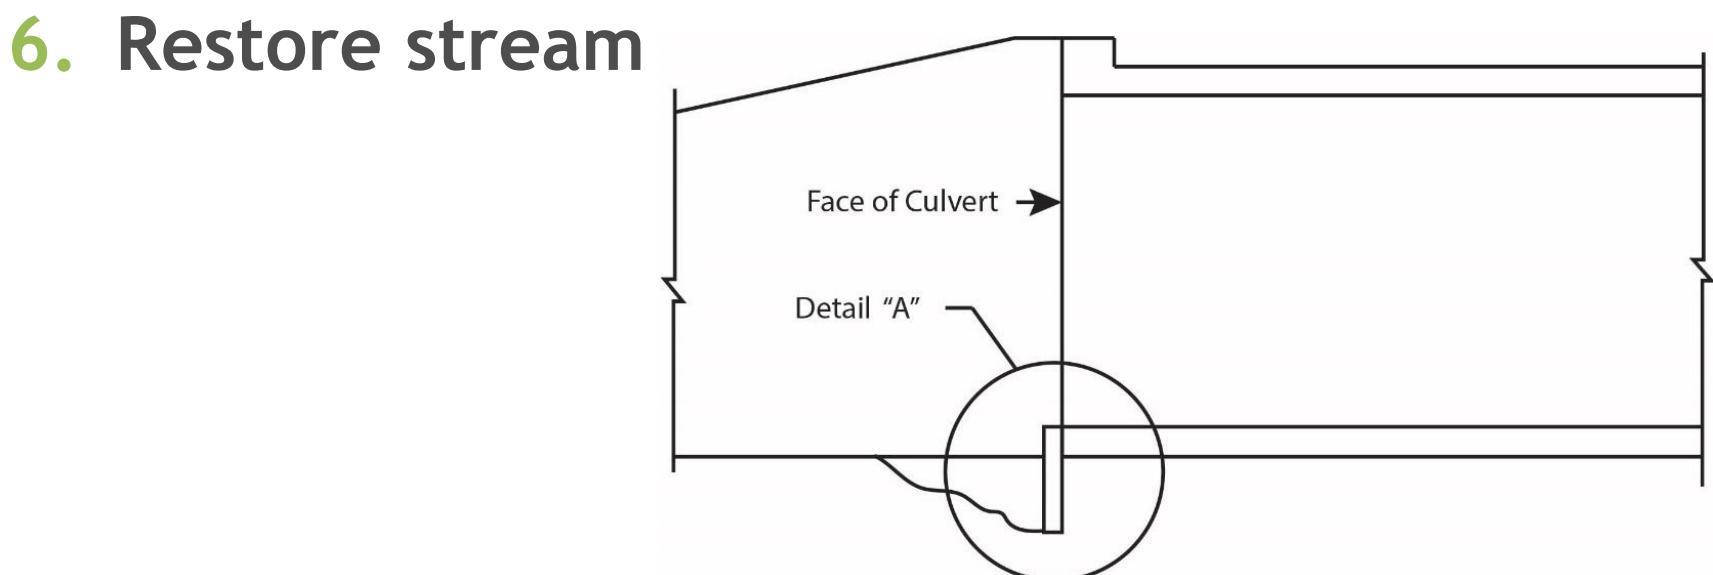
Undermining Repairs > Toe Wall Installation

- 1. Divert stream
- 2. Form toe wall
- 3. Anchor toe wall to culvert
- 4. Place concrete and cure
- 5. Backfill with scour resistant material

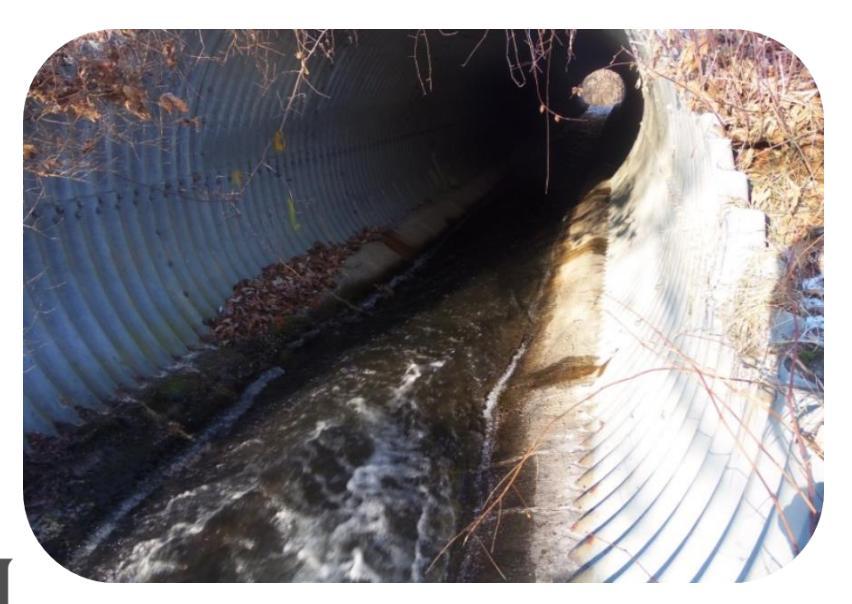
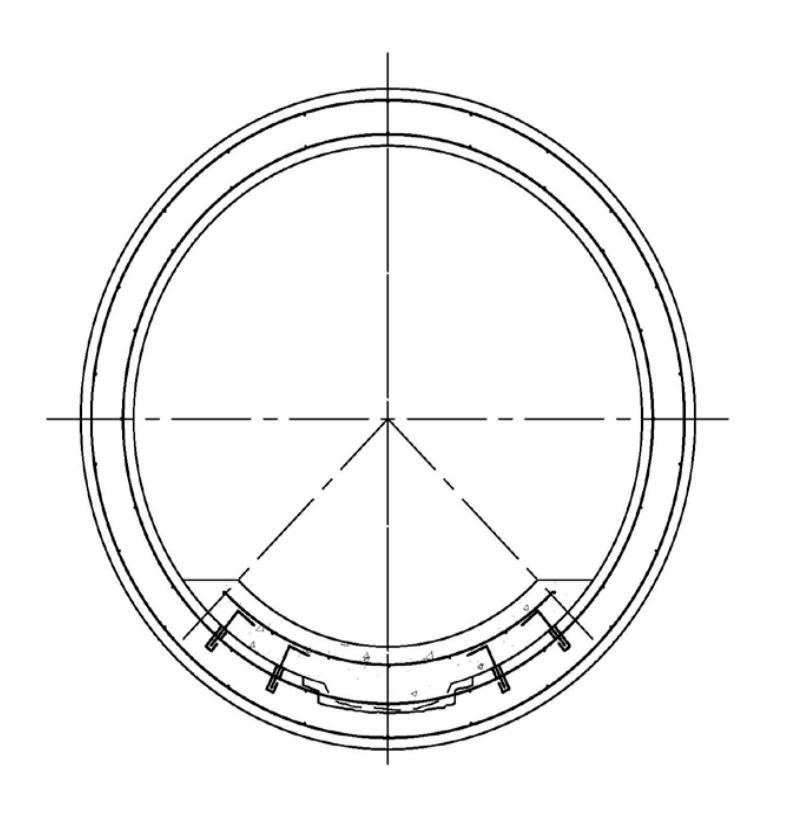
Concrete Paved Invert Repairs

- Perform stream diversion
- Clean area of invert to be paved
- Form and place concrete
- Cure adequately
- Restore stream flow

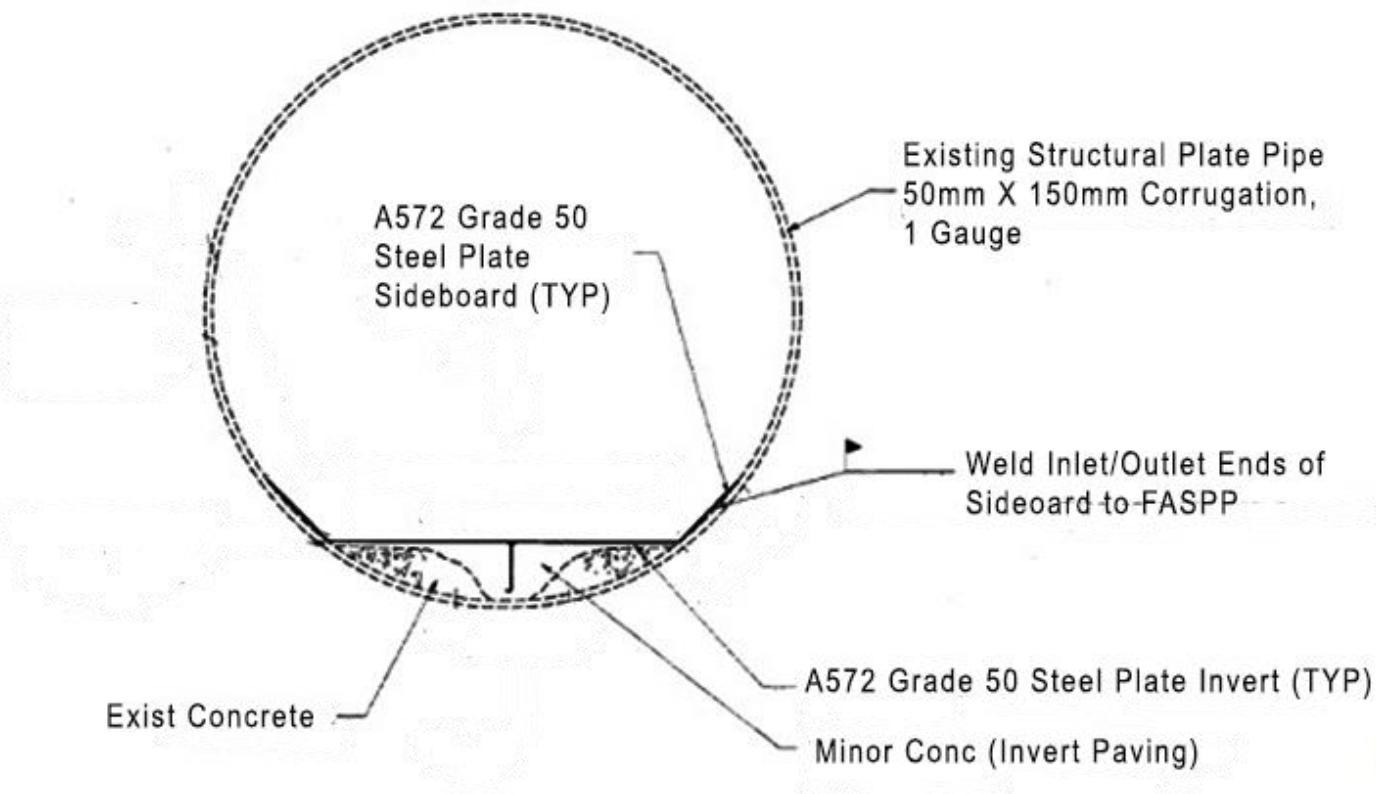
Invert Repairs> Armor Plates

- For severe abrasion of the invert
- Spreads flow
- Resists abrasion

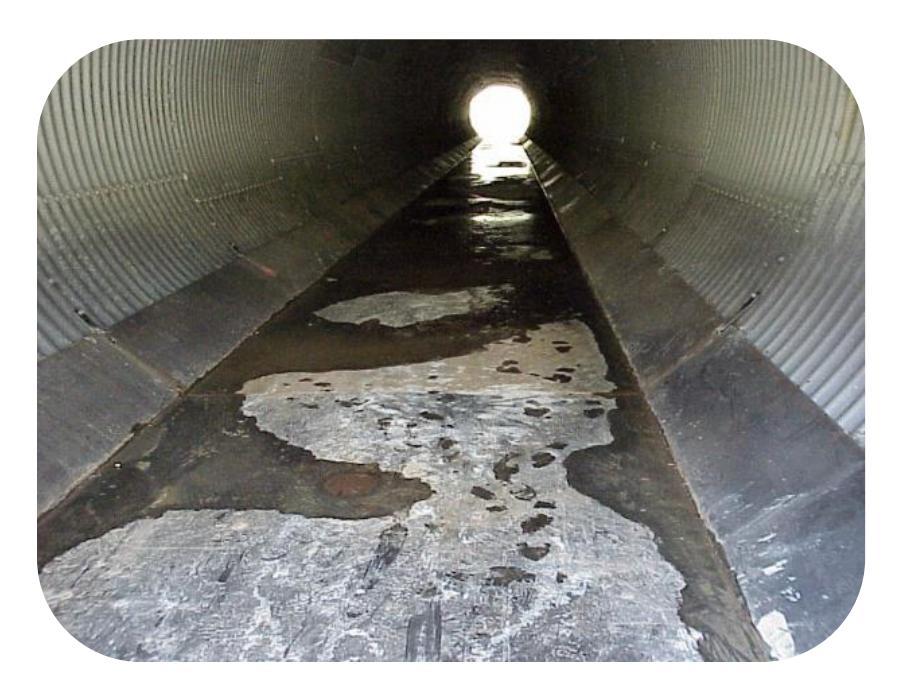
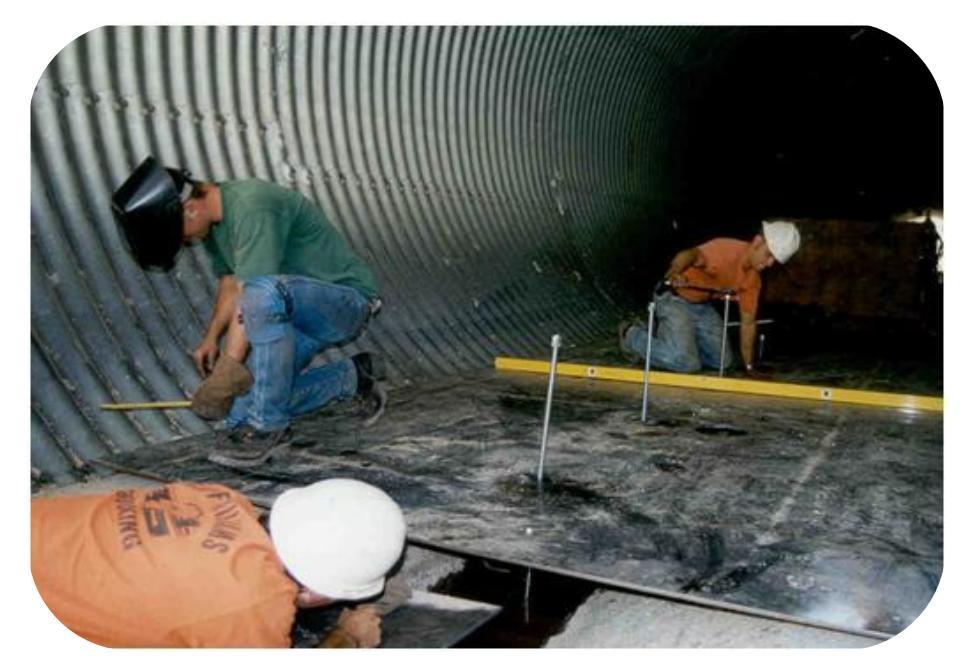
Armor Plates (con.)

- Important to securely attach plates to host pipe
- Concrete between armor plate and culvert invert

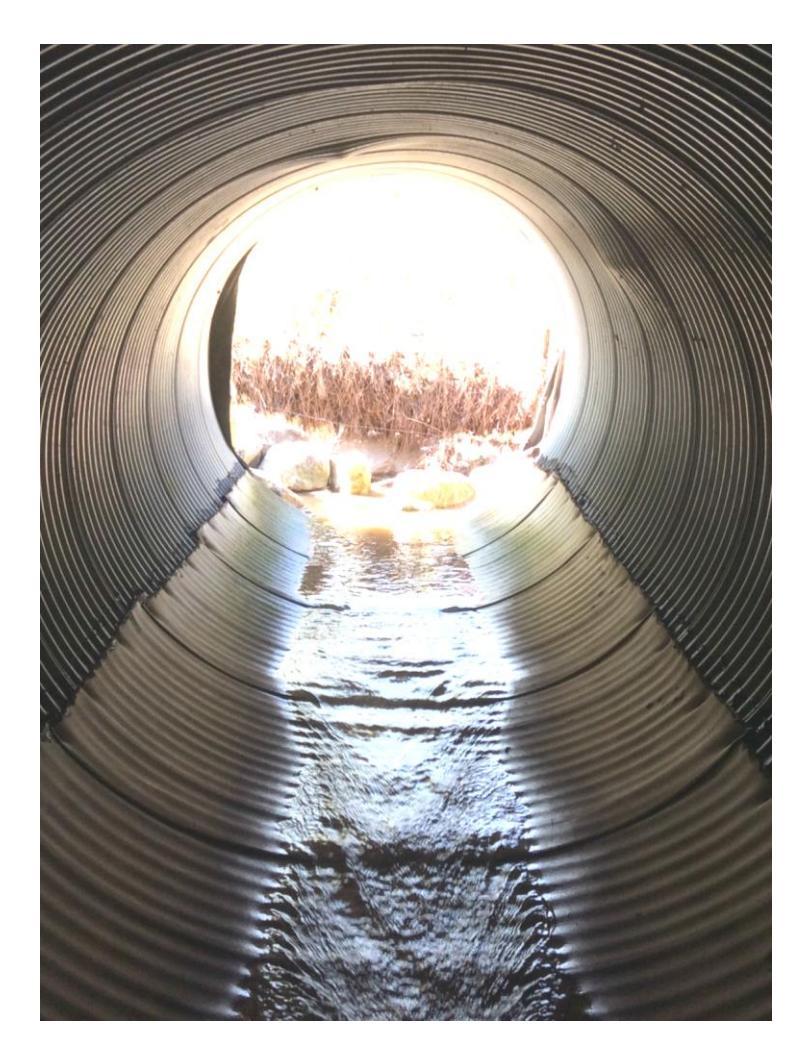
Invert Repairs> Geosynthetic Cementitious Composite Mat

- 1. Perform stream diversion
- 2. Clean area of invert to be paved
- 3. Place mat in invert in shingle pattern and anchor to culvert
- 4. Hydrate and cure mat
- 5. Restore stream flow

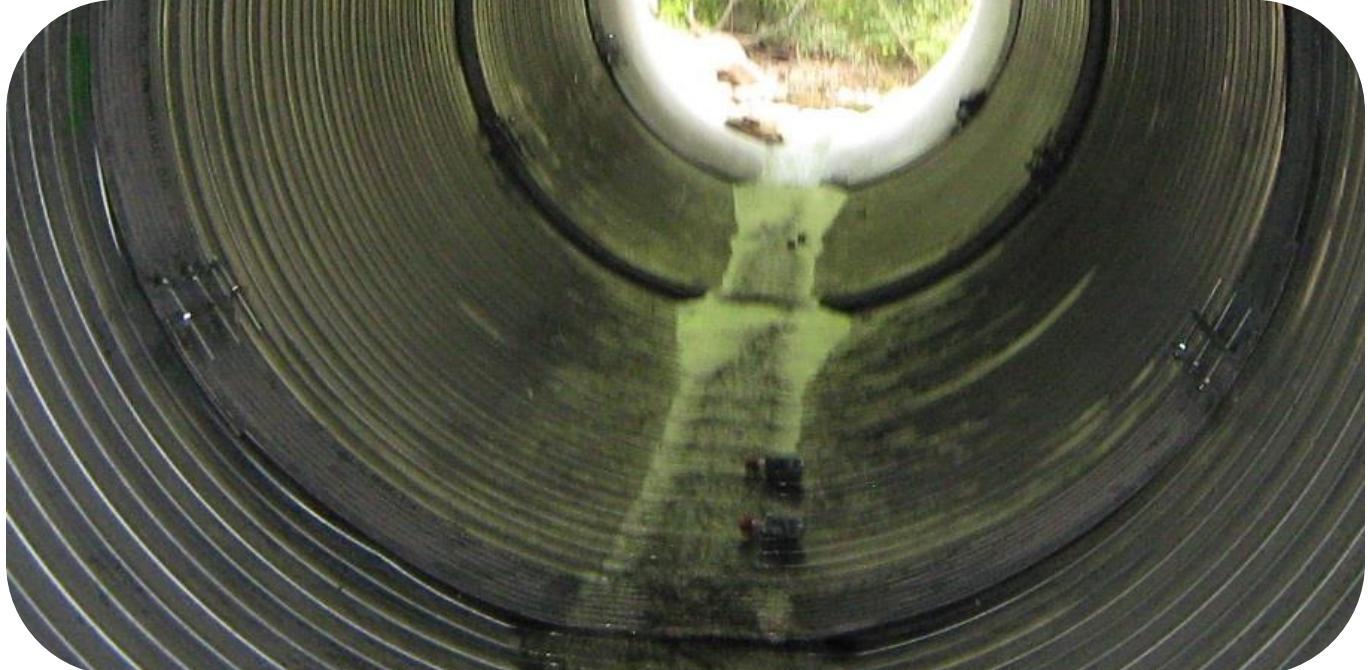
Joint Repair> Internal Bands

- Soil tight
- Does not need to be water tight
- Bands placed over the joint
- Tightened into place with threaded rods

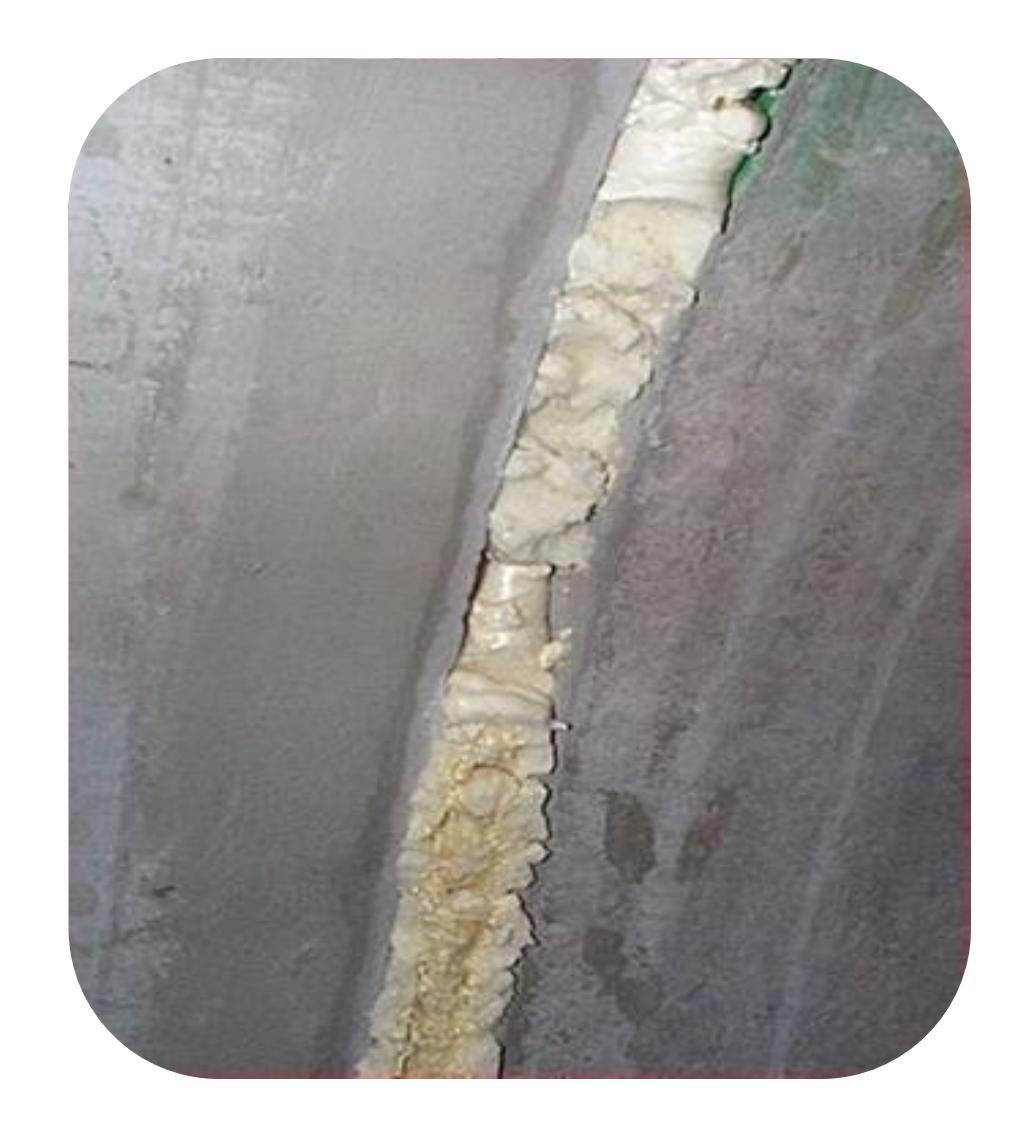
Joint Repair > Flexible Chemical Grout Injection

- Grout injected through the open joints

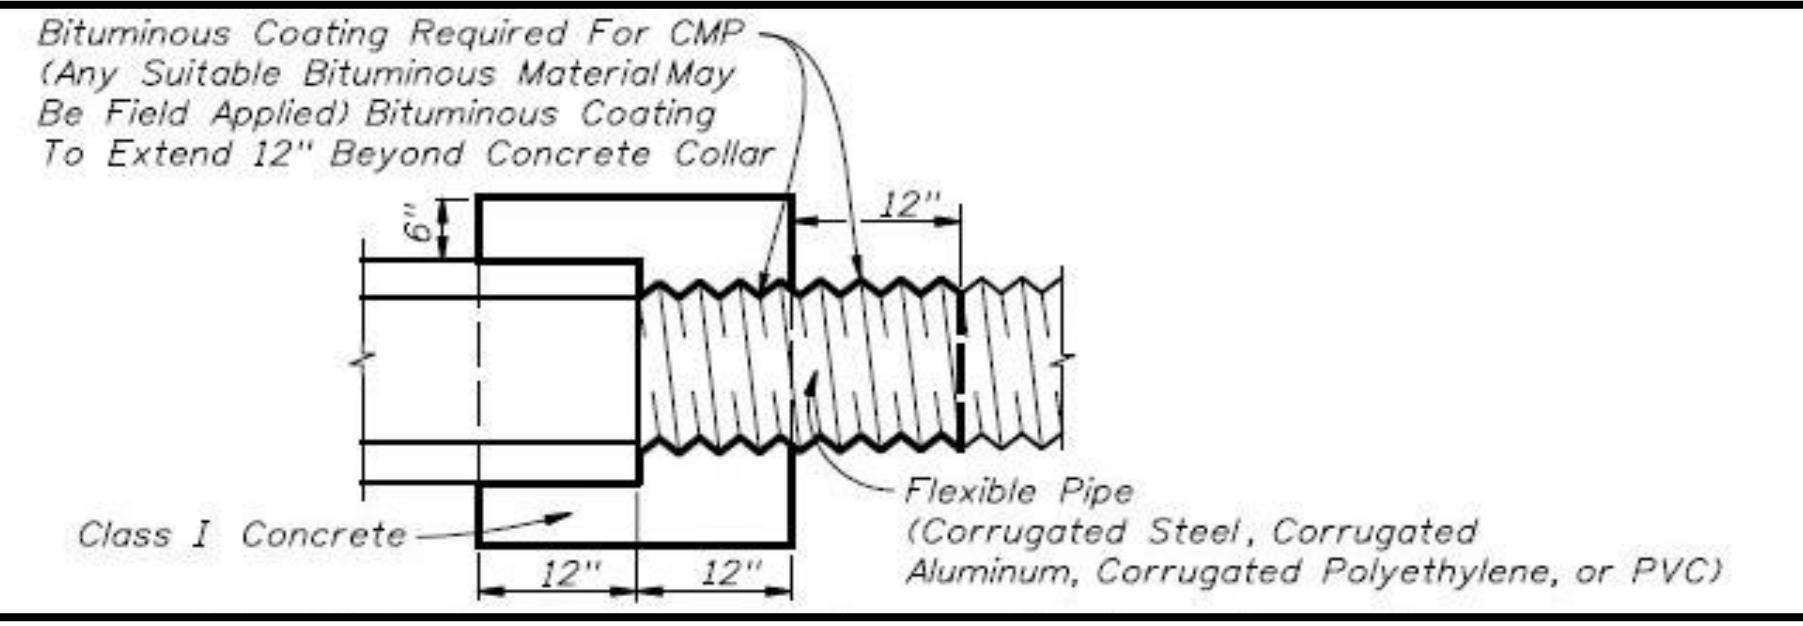
Joint Repair > Concrete Collar Installation

- Excavate pipe to expose joint
- Excavate beneath joint and compact
- Form area of concrete collar
- Place concrete and backfill

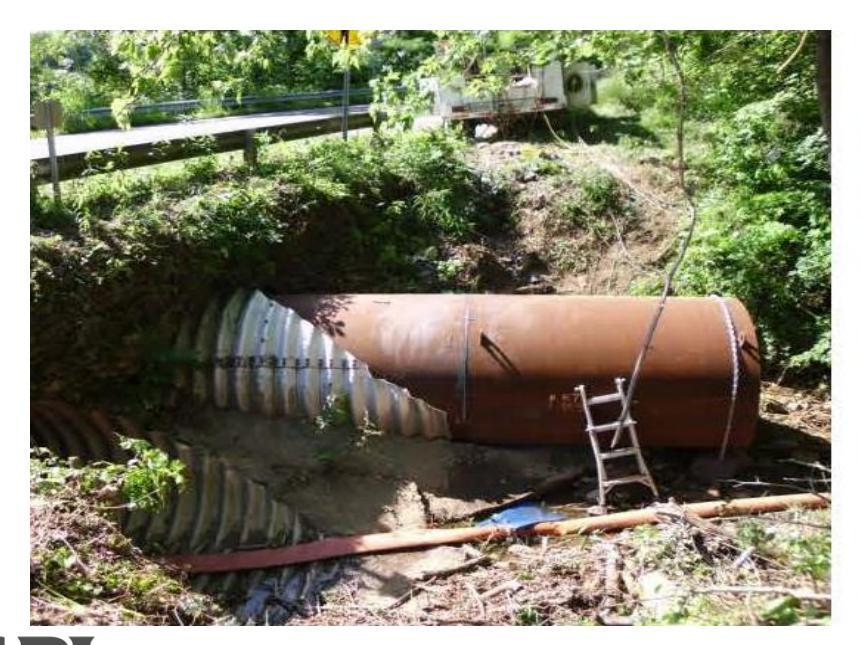
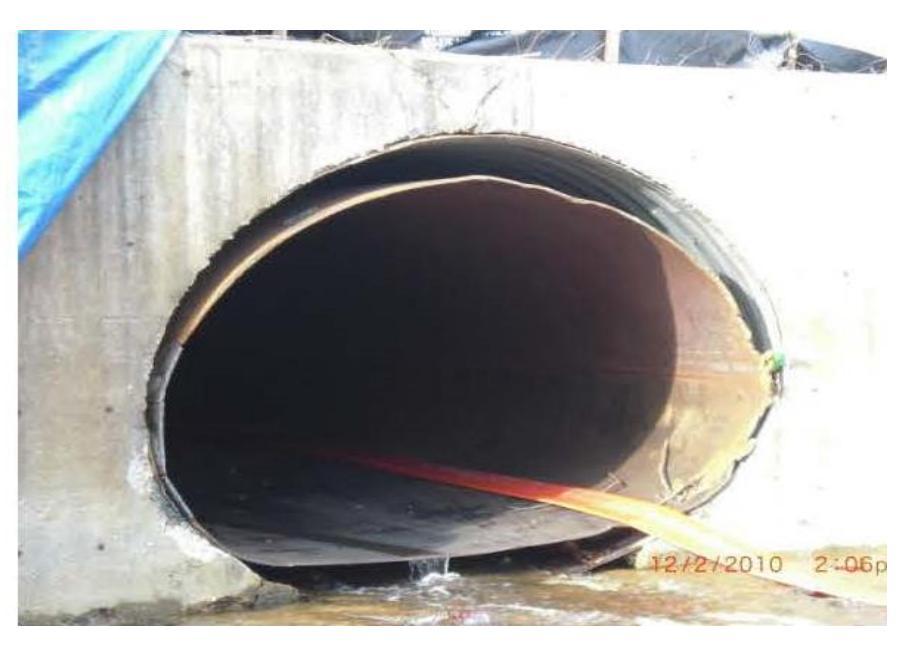
Relining Culverts > Slip Lining

- Corrugated Metal Pipe
- Corrugated Metal Plate Pipe/Plate Arch
- Smooth Interior Metal Pipe
- High Density Polyethylene Pipe

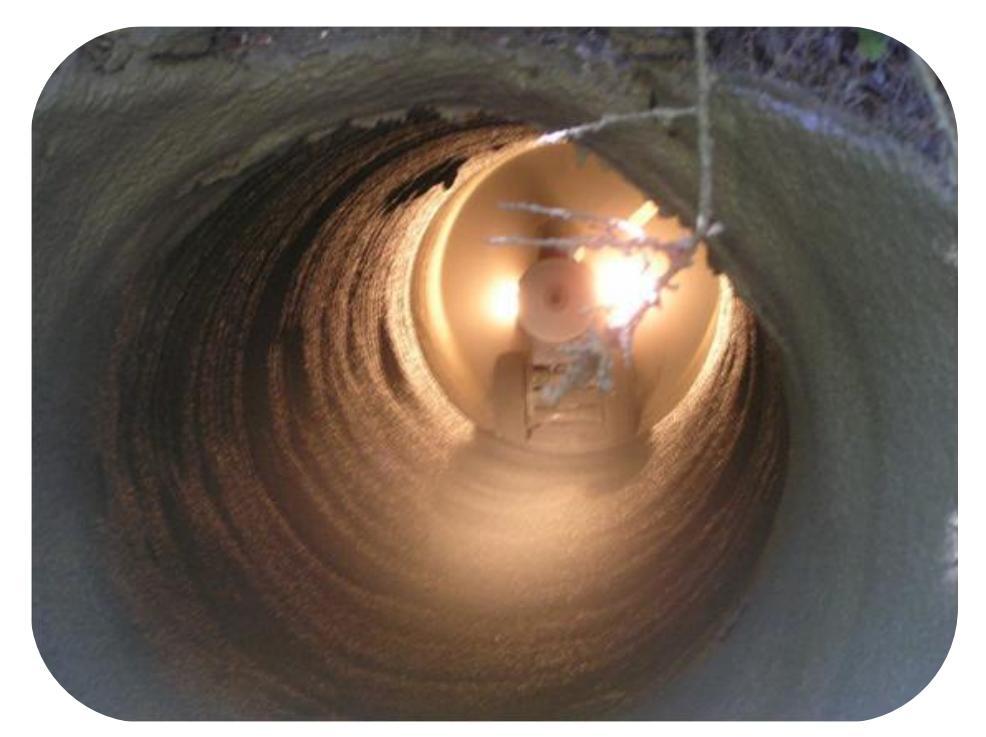
Relining Culverts> Shotcrete & Spin Cast Concrete Liner

- Concrete interior
- Liner is uniform thickness over existing culvert
- Is more forgiving of distortions
- Cleaning and grouting voids before
