Engineering | Design | Planning | Construction Management

Maintenance & Preservation Techniques for Metal Culverts

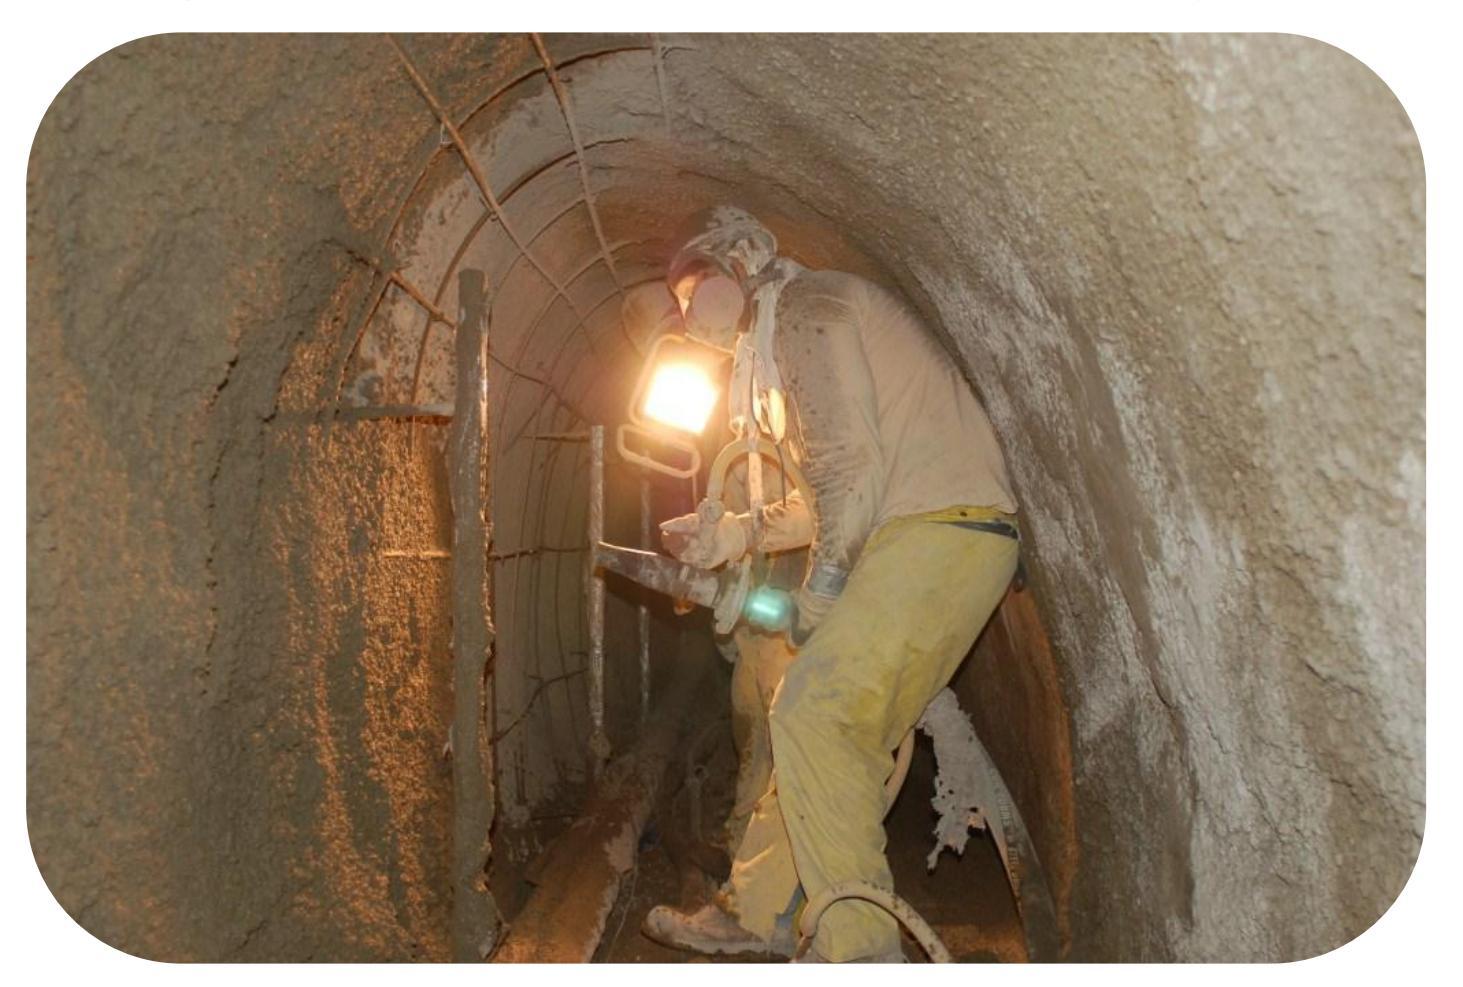
Relining Culverts> Shotcrete & Spin Cast Concrete Liner (con.)

For larger culverts shotcrete may be used

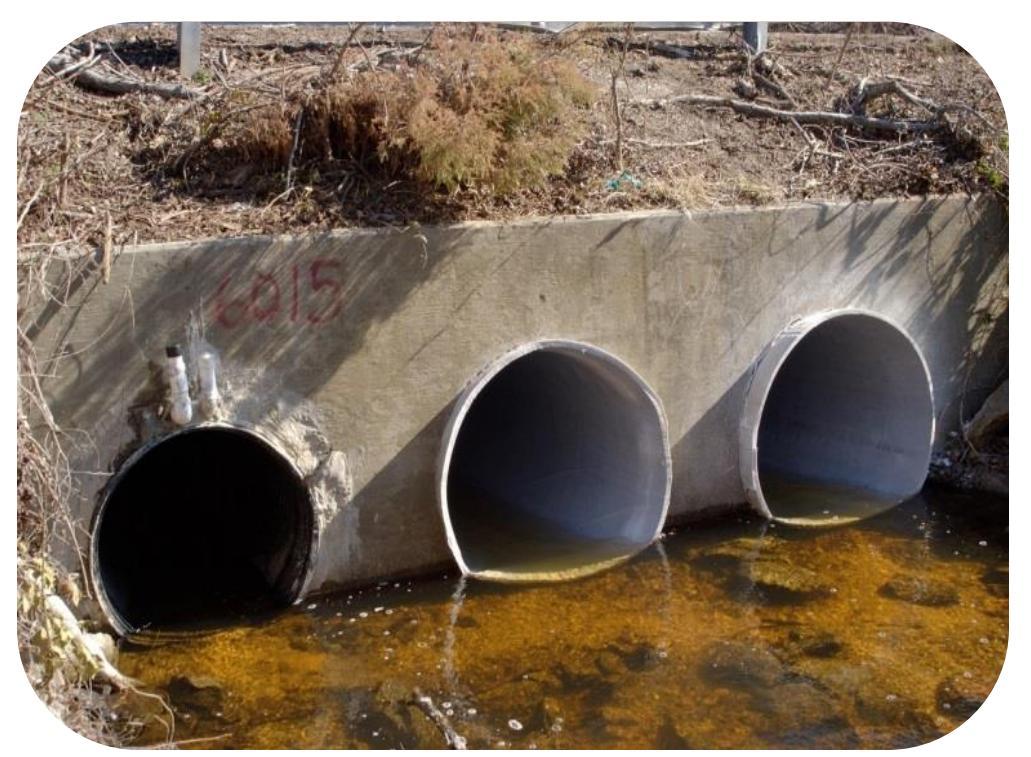
Relining Culverts > Cured-In-Place Pipe (CIPP)

- Resin Impregnated Felt liner
- Installed using water or air pressure
- Cured with hot water or hot air
- Takes culvert out of service during cure

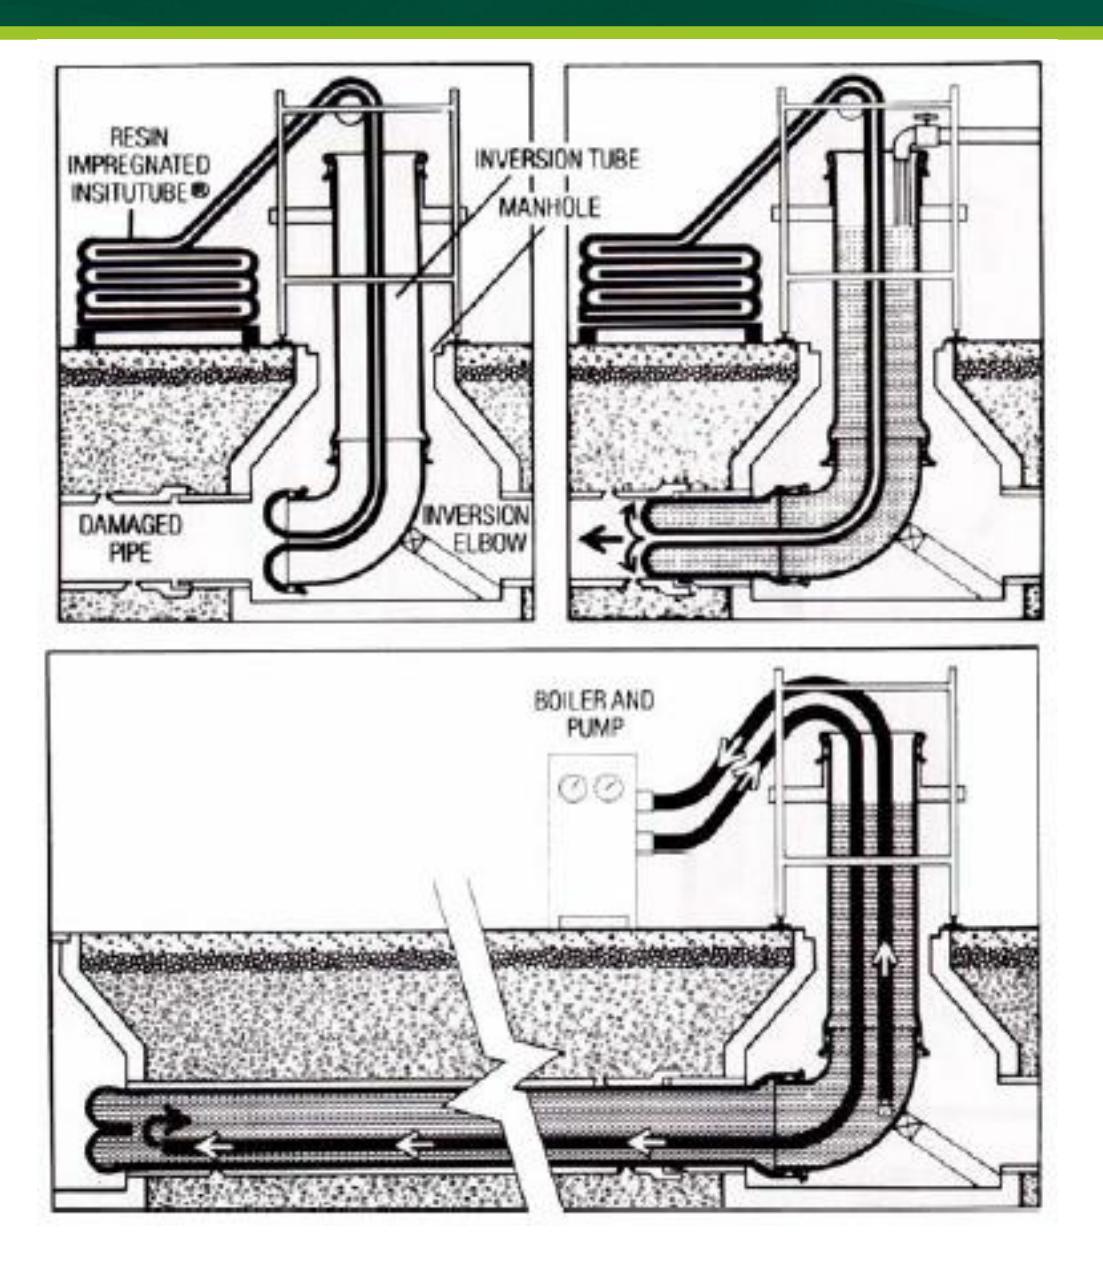
Relining Culverts > Cured-In-Place Pipe (CIPP) (con.)

Inversion or installation process

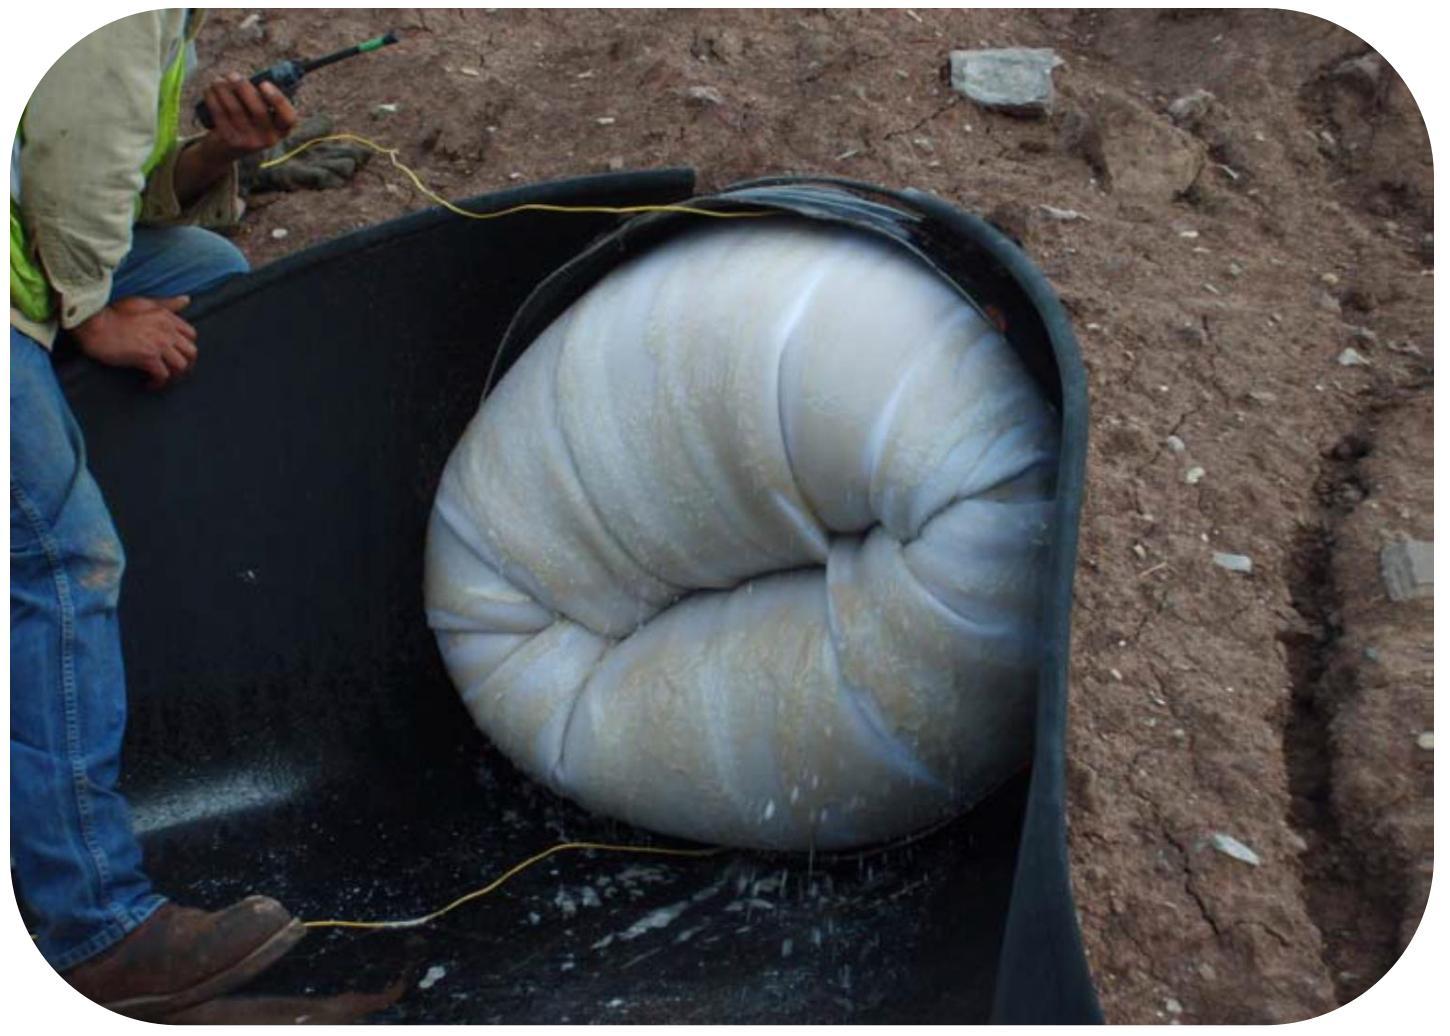
Relining Culverts > Cured-In-Place Pipe (CIPP) (con.)

Inversion Complete

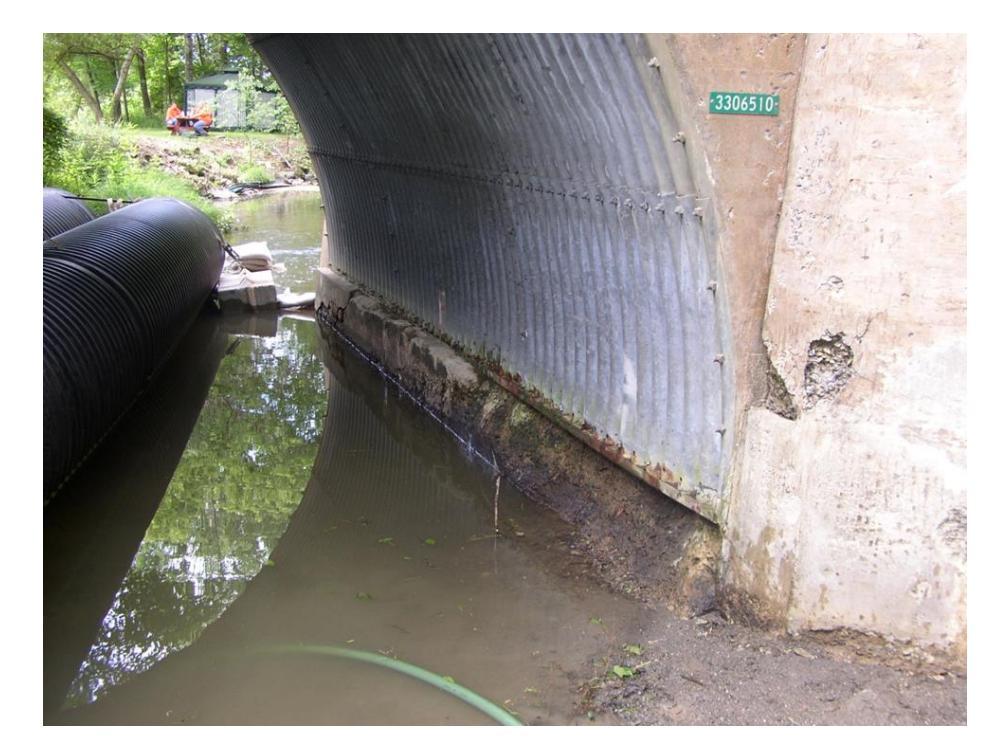
Footing Repair of Bottomless Culverts (con.)

- 1. Place coffer dam/bypass pipe
- 2. Determine extent of repairs
- 3. Remove unsound concrete
- 4. Repair reinforcing steel
- 5. Clean area and form

- Similar to concrete pier or abutment repairs
- Tight spaces making equipment use difficult
- Stream diversions necessary
- Assessment of extent of sound concrete needed
- Extensive repairs may need to extend below scour depth

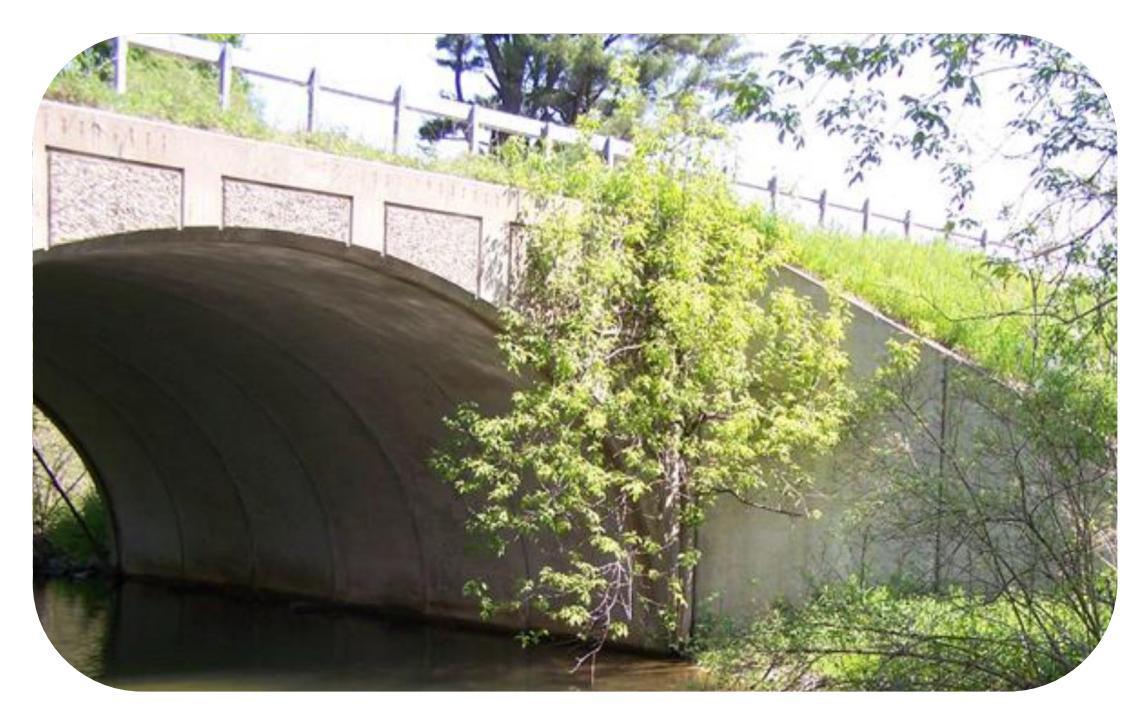
Footing Repair of Bottomless Culverts (con.)

- 1. Place bonding agent if used
- 2. Place concrete
- 3. Cure concrete
- 4. Remove forms and re-stablish stream
